# **Environmental Dust Assessment Report (October 2023)**

**Tweed Valley Hospital Project, Cudgen NSW**

Prepared for: Lendlease Building Pty Ltd

A101021.0286.00 | EDM50.Rev0 | Date: 10/11/2023

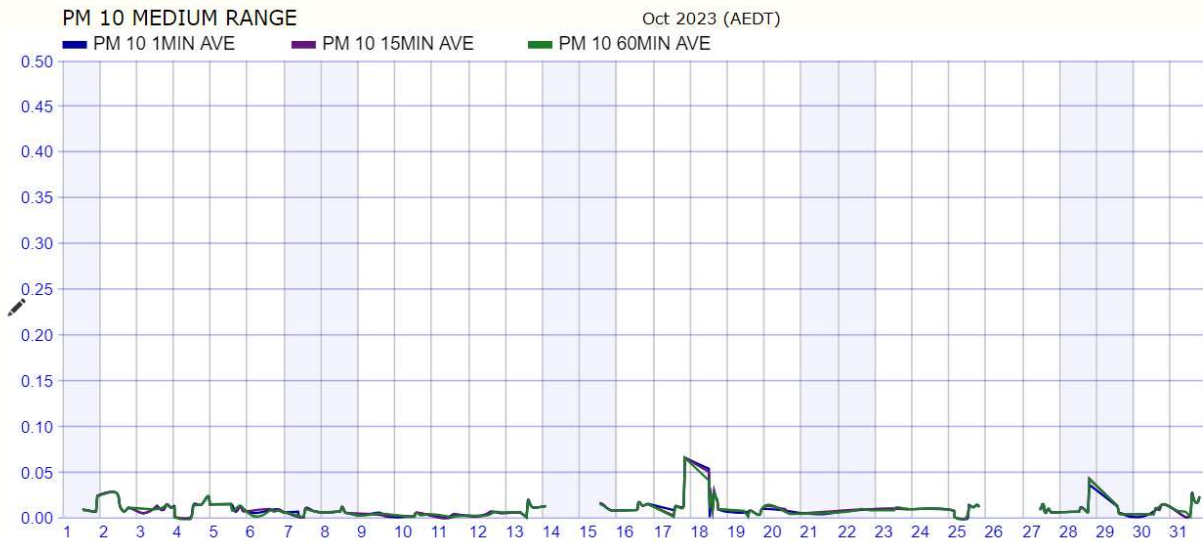
Dust Monitor 005 was observed to be offline sporadically throughout October.

**Figure 1.** Summary of PM10 from the real time monitoring at location 005 – Solar Industry for the month of October 2023.

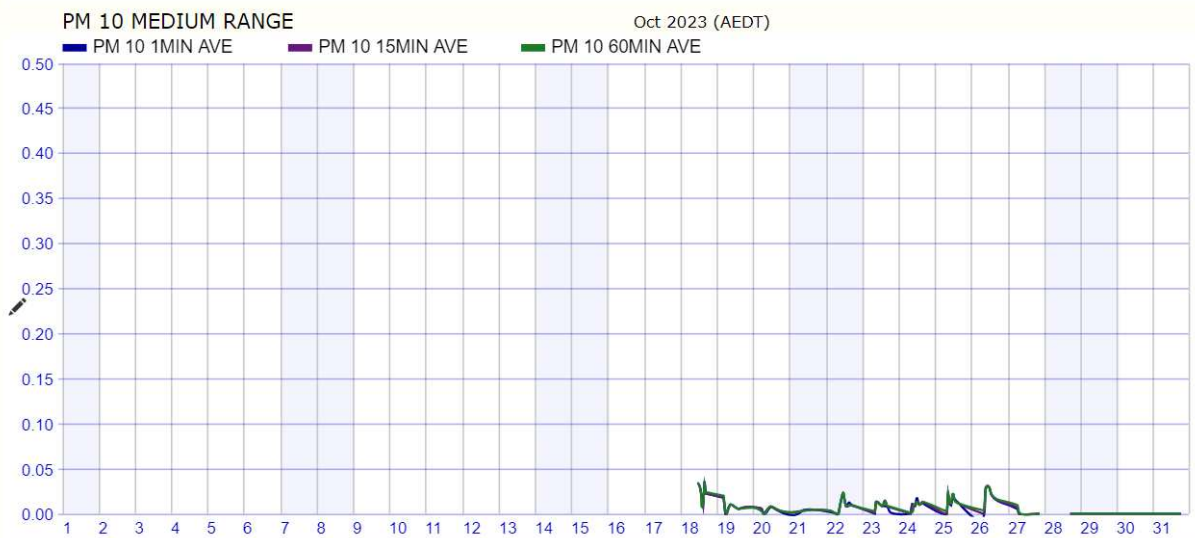
During the reported monitoring period, data was missing from the 1<sup>st</sup> to the 18<sup>th</sup> of October.

**Figure 2.** Summary of PM10 from the real time monitoring at location 006 – Mate and Matts for the month of October 2023.

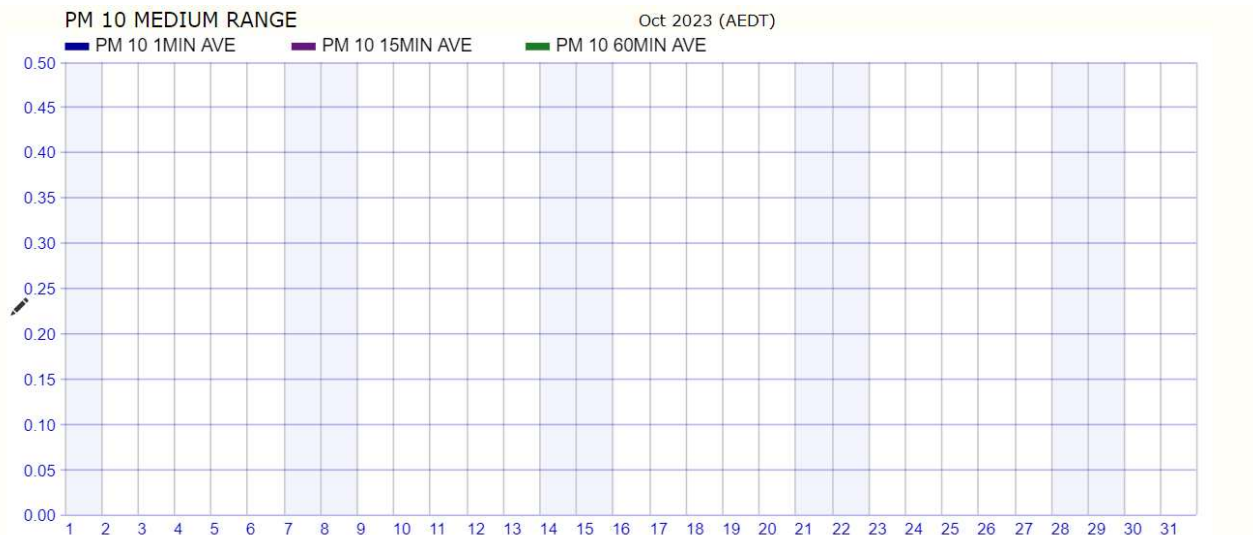
During the reported monitoring period, data was missing for the month of October.

**Figure 3.** Summary of PM10 from the real time monitoring at location 007 – Residential for the month of October 2023.

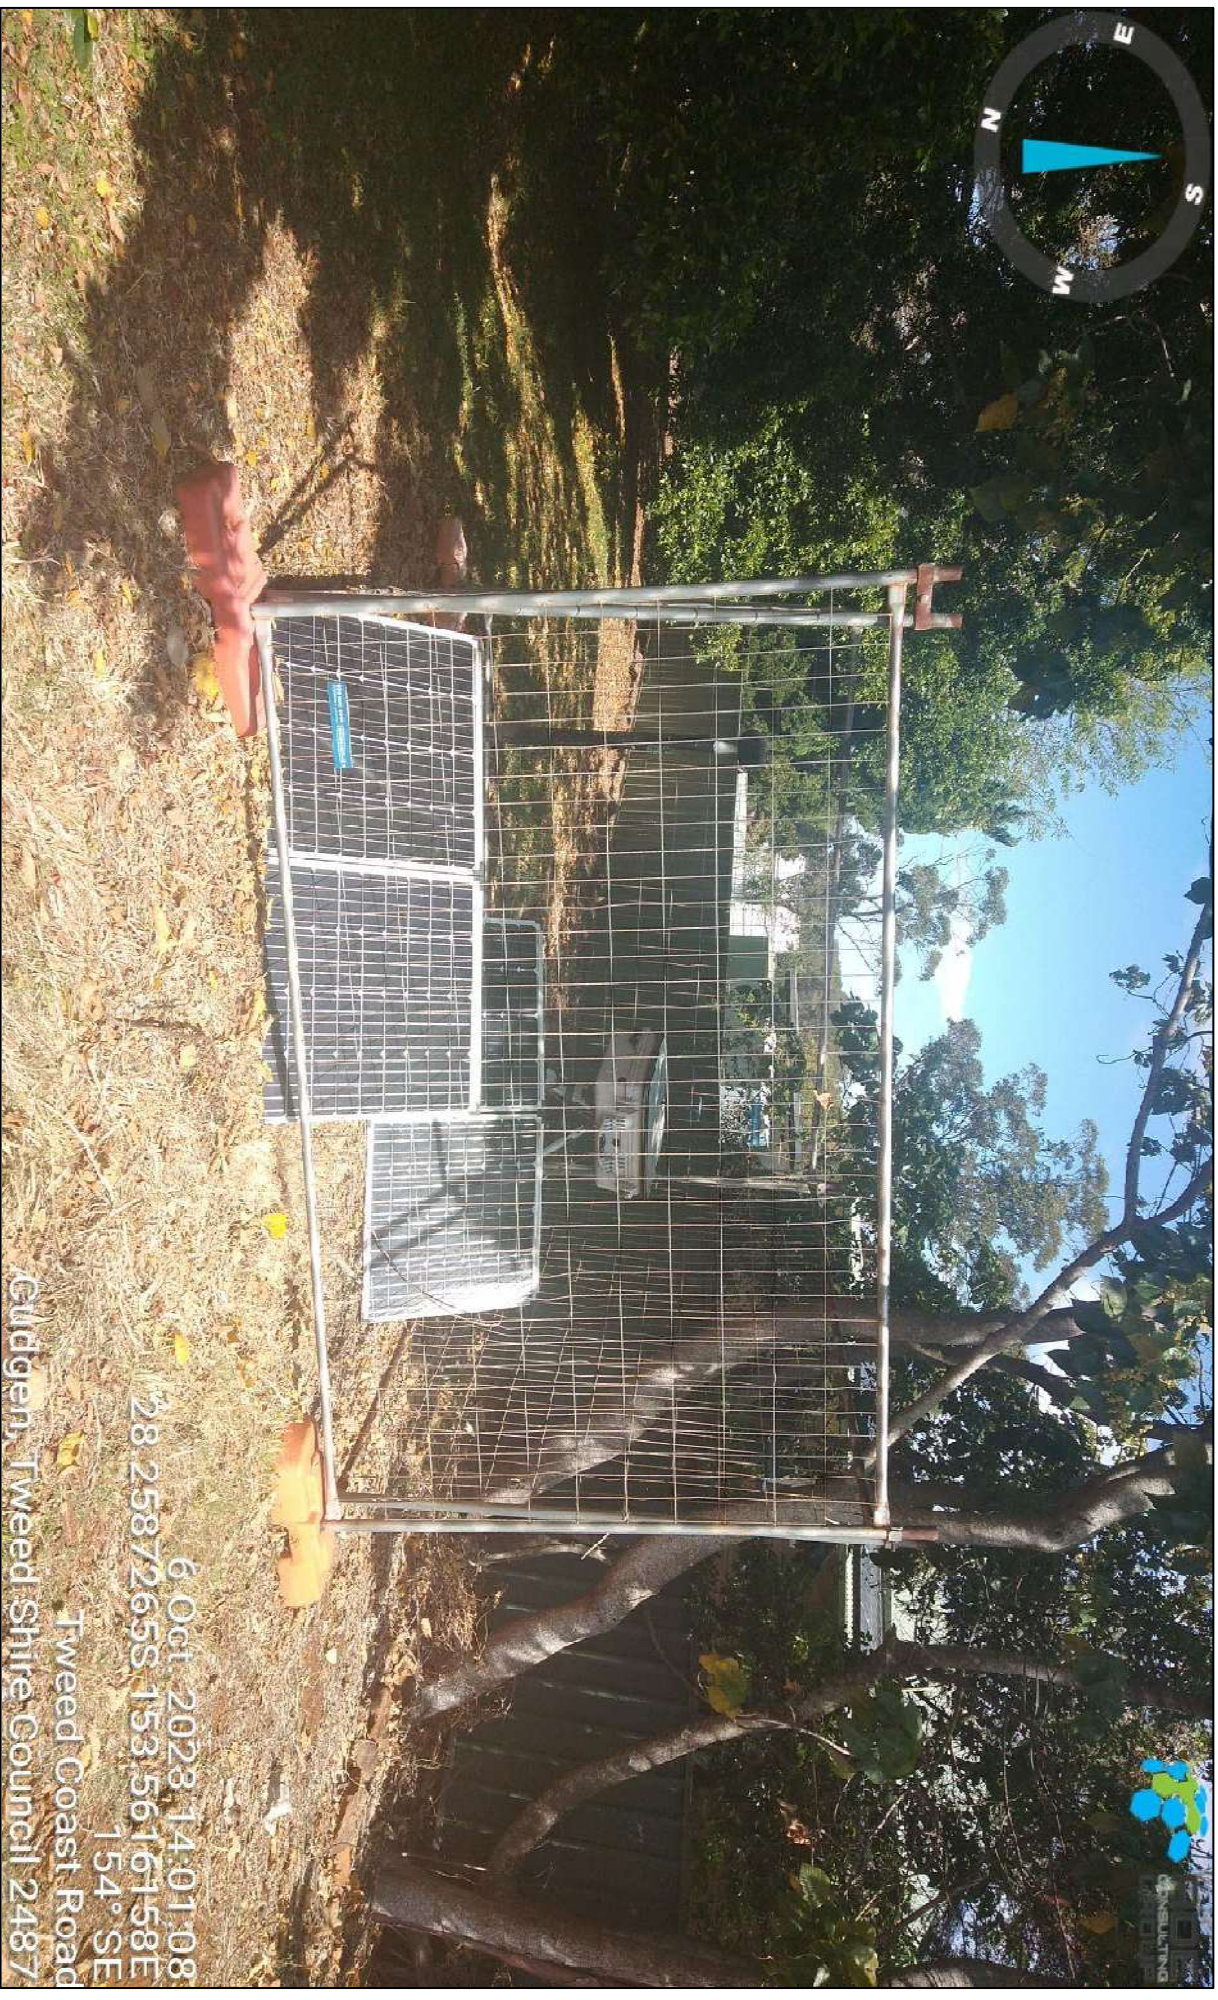
Photograph 1: Representative photograph of monitoring location 005 – Solar Industry, as observed 6/10/2023

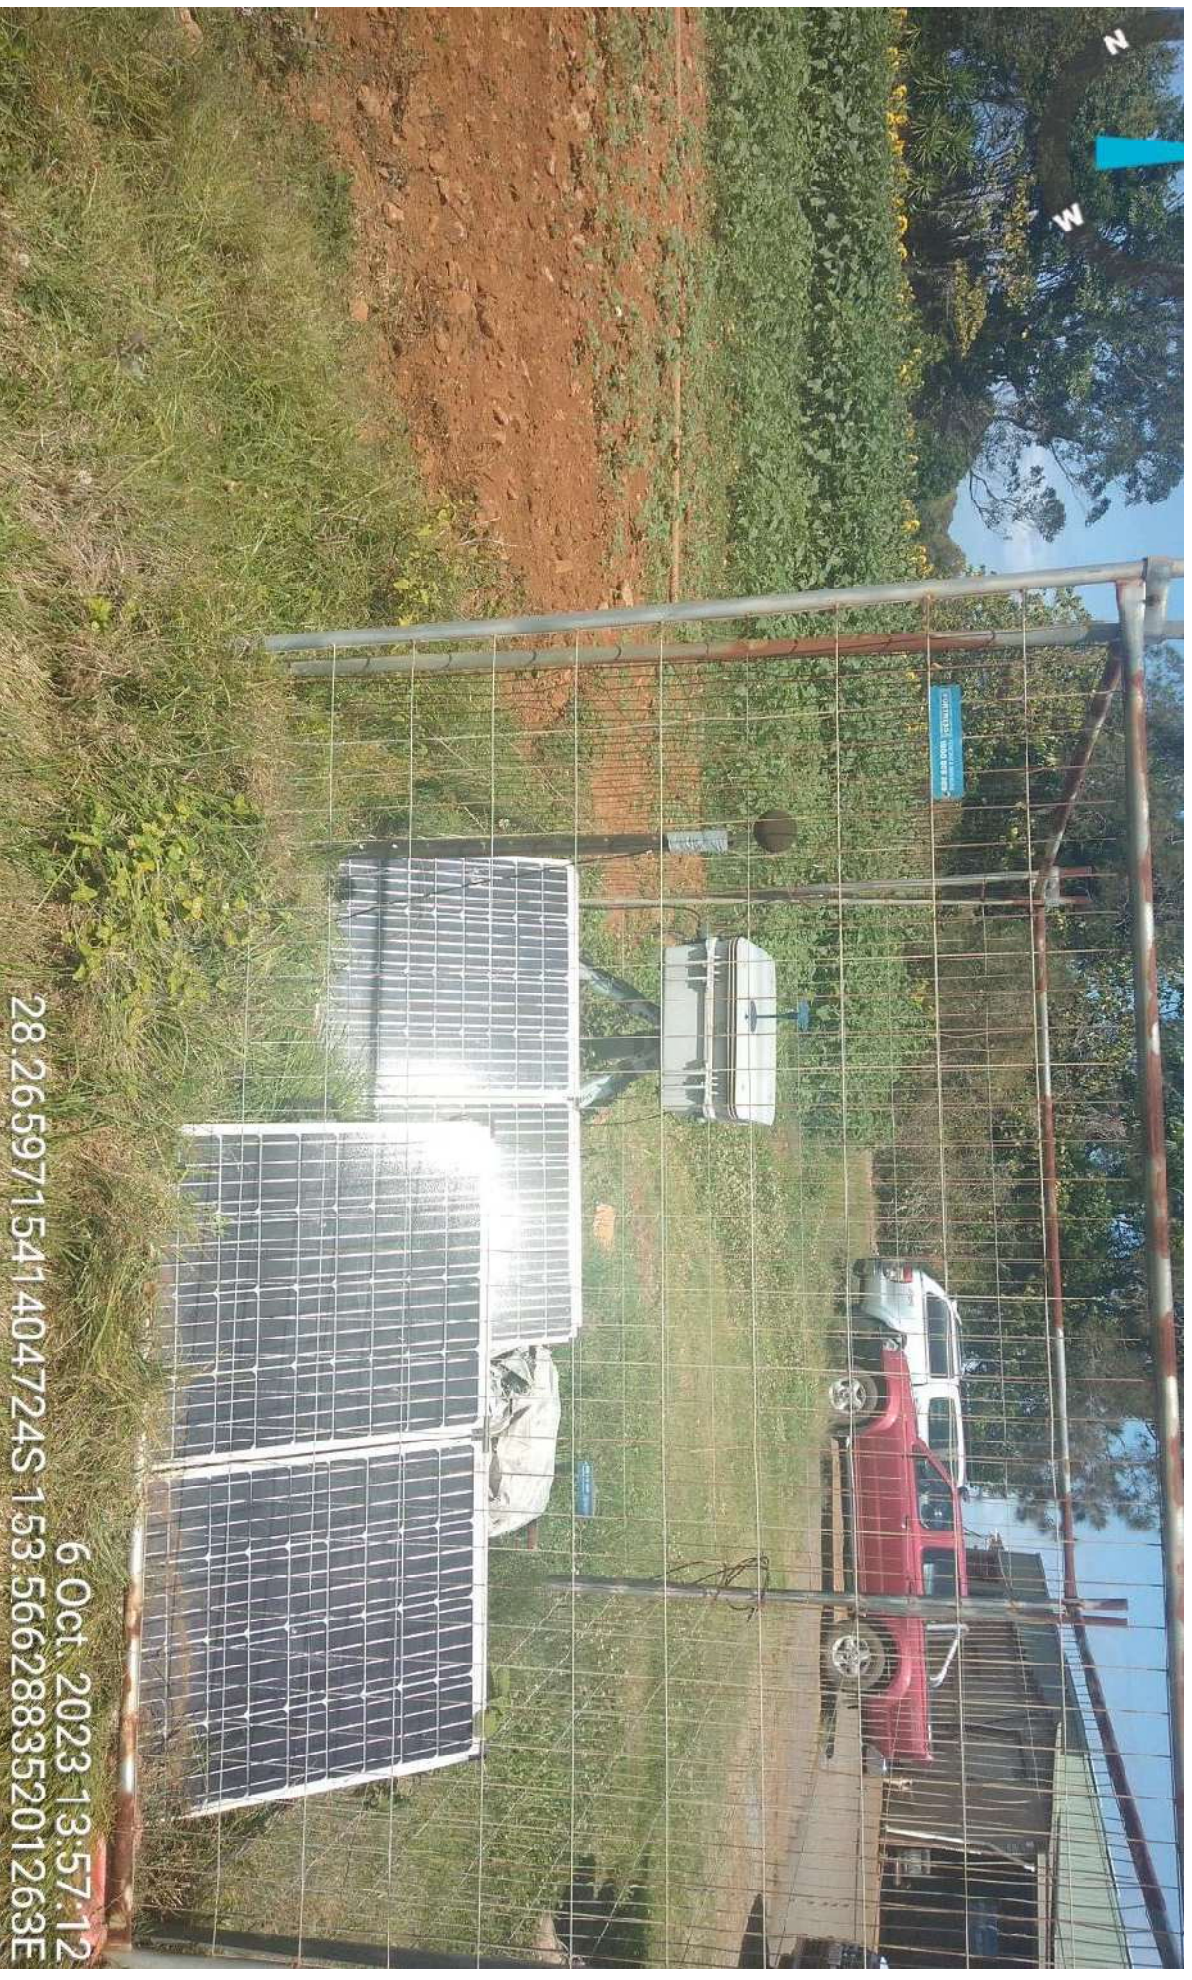
Photograph 2: Representative photograph of monitoring location 006 – Mate and Matts, as observed 6/10/2023

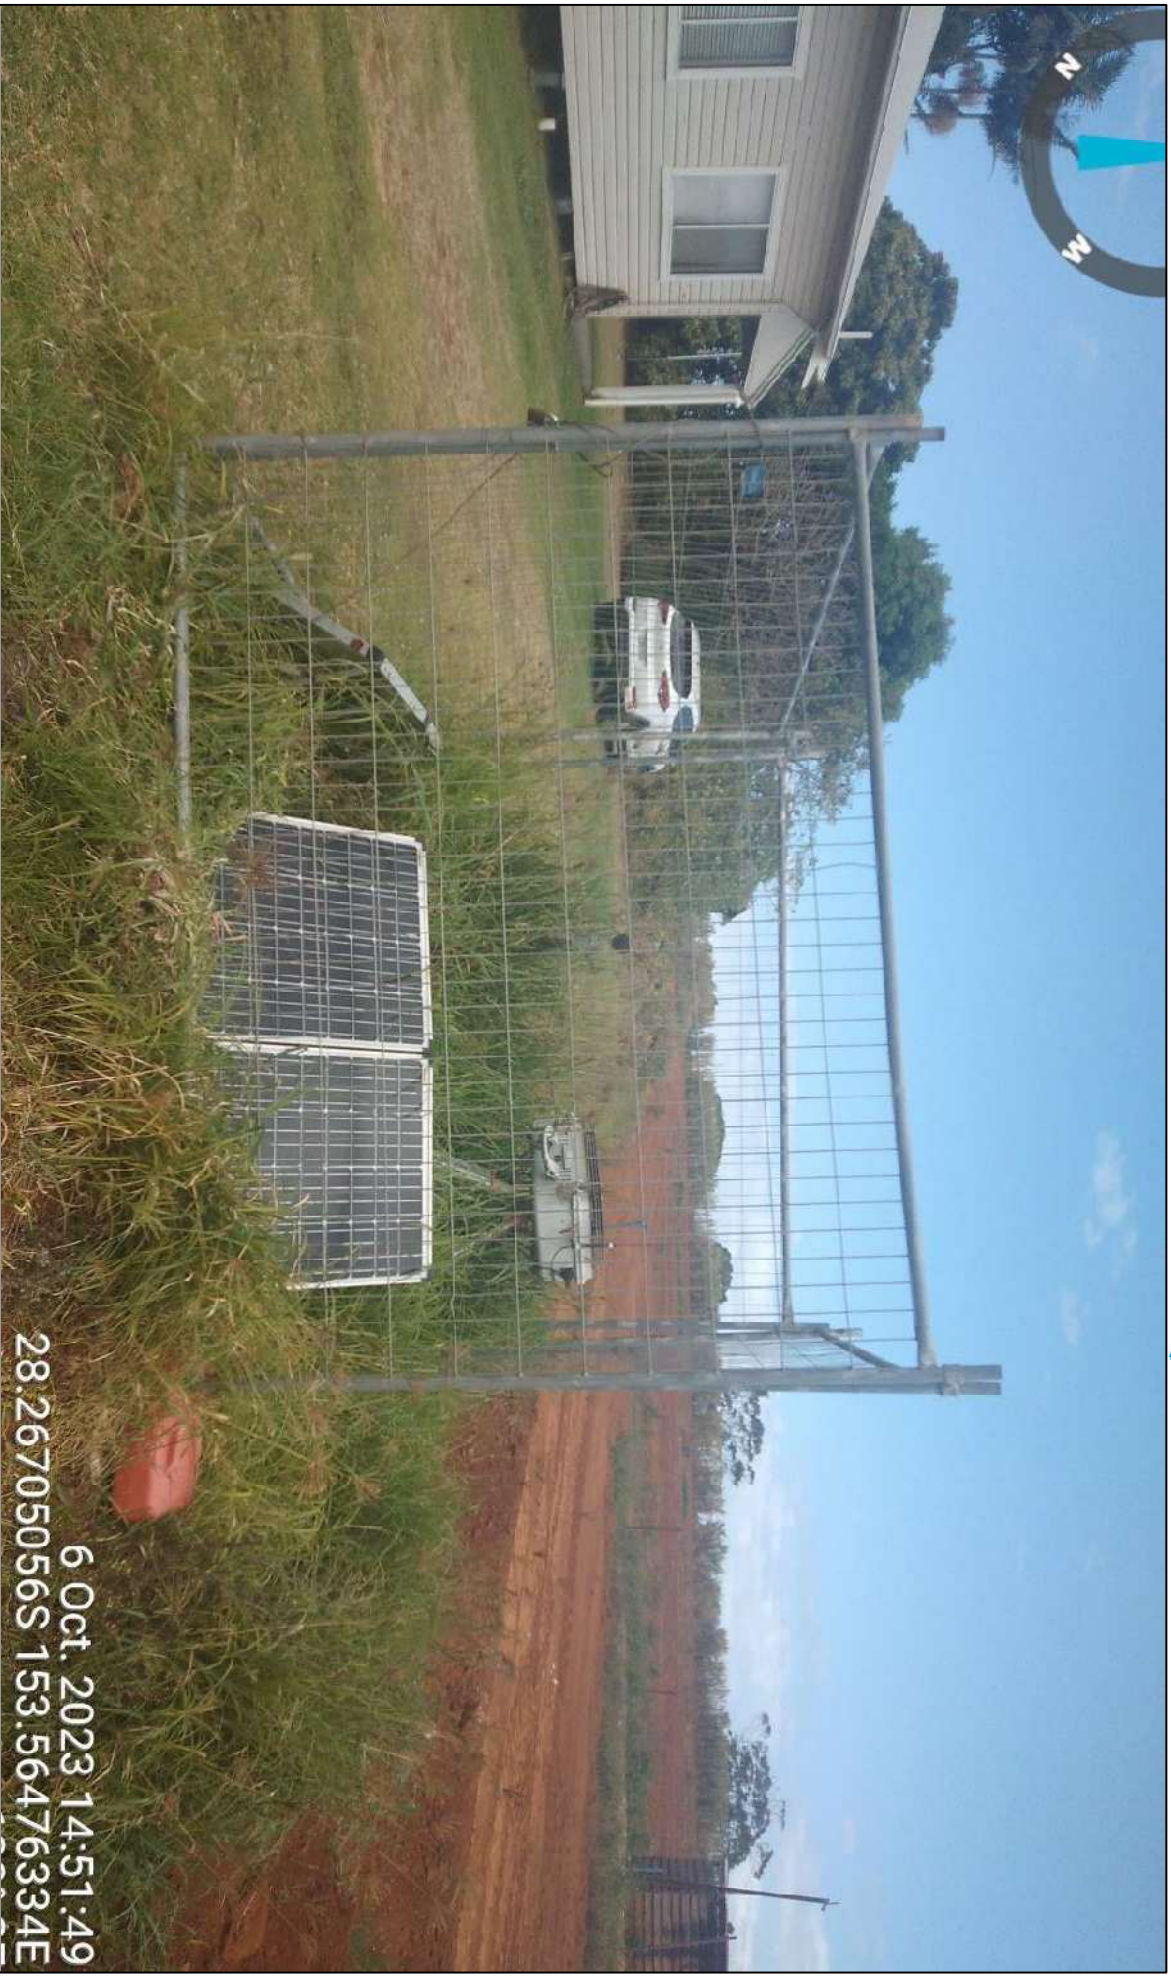
Photograph 3: Representative photograph of monitoring location 007 – Residential, as observed 6/10/2023
