# **Environmental Dust Assessment Report (September 2023)**

**Tweed Valley Hospital Project, Cudgen NSW**

A101021.0286.00 | EDM49.Rev0 | Date: 10/11/2023

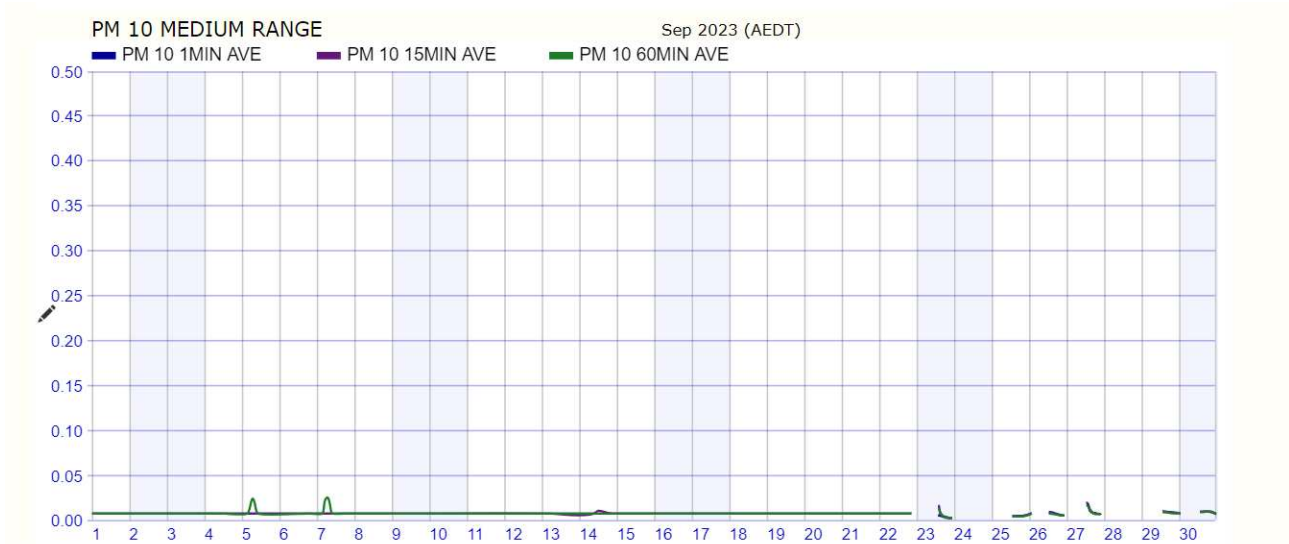
Dust Monitor 005 was observed to be offline sporadically towards the end of September.

Sporadic data gaps were identified at Monitoring Location 005 during the end of the month of September due to an insufficient power supply. ADE considers the likelihood of dust exceedances to have occurred at Monitoring Location 005 is very low to negligible due to current site works and historical data obtained.

**Figure 1.** Summary of PM10 from the real time monitoring at location 005 – Solar Industry for the month of September 2023.

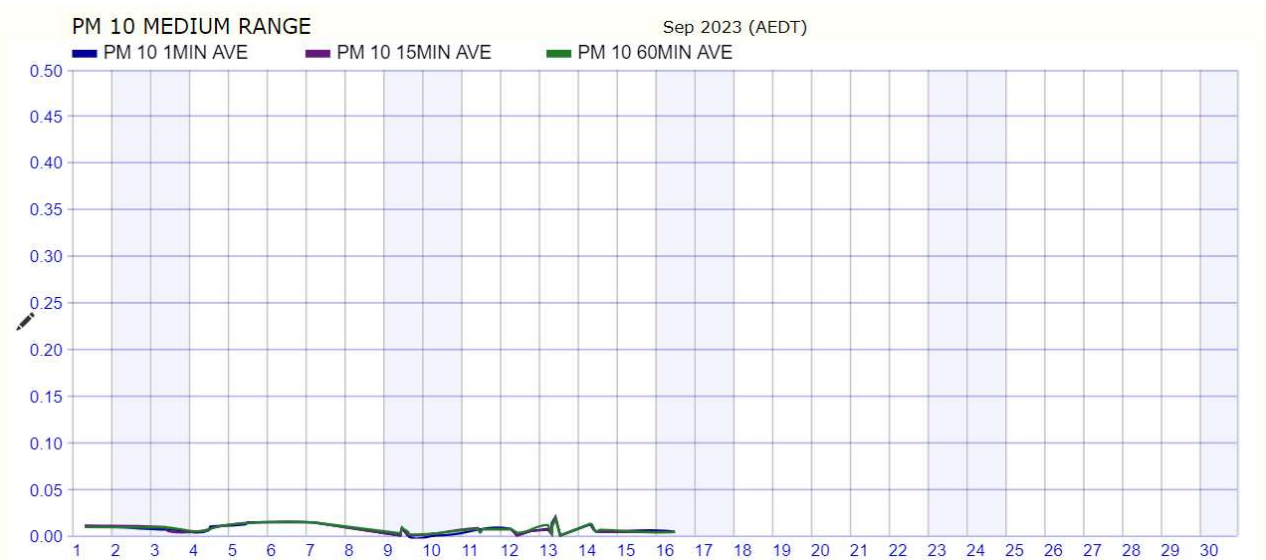
During the reported monitoring period, data was missing from the 17<sup>th</sup> to the 30<sup>th</sup> of September.

**Figure 2.** Summary of PM10 from the real time monitoring at location 006 – Mate and Matts for the month of September 2023.

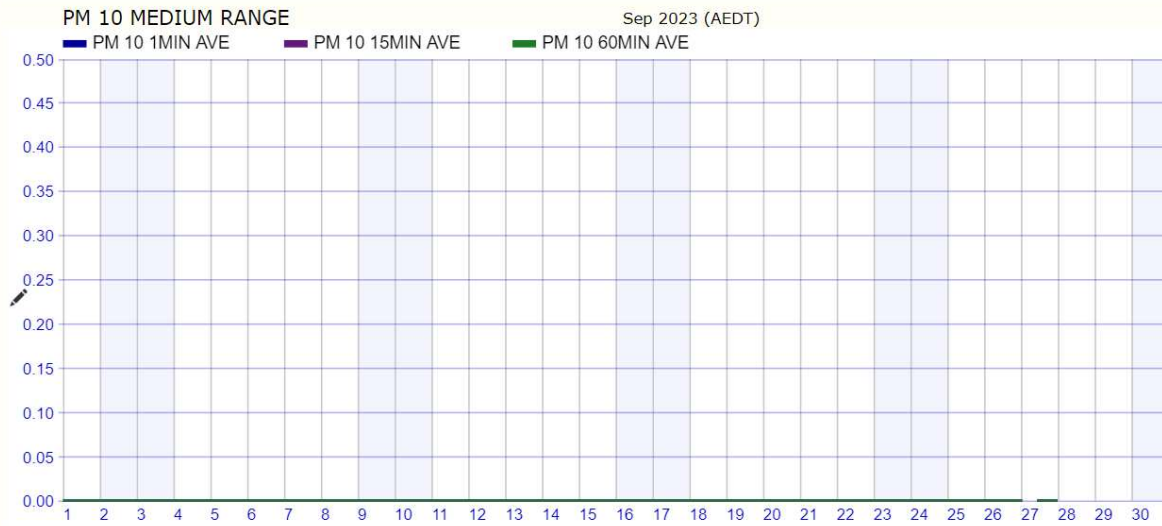
During the reported monitoring period, data was missing from the 27<sup>th</sup> to the 30<sup>th</sup> of September.

**Figure 3.** Summary of PM10 from the real time monitoring at location 007 – Residential for the month of September 2023.
