Environmental Dust Assessment Report (August 2023)

Tweed Valley Hospital Project, Cudgen NSW

A101021.0286.00 | EDM48.Rev0 | Date: 10/11/2023

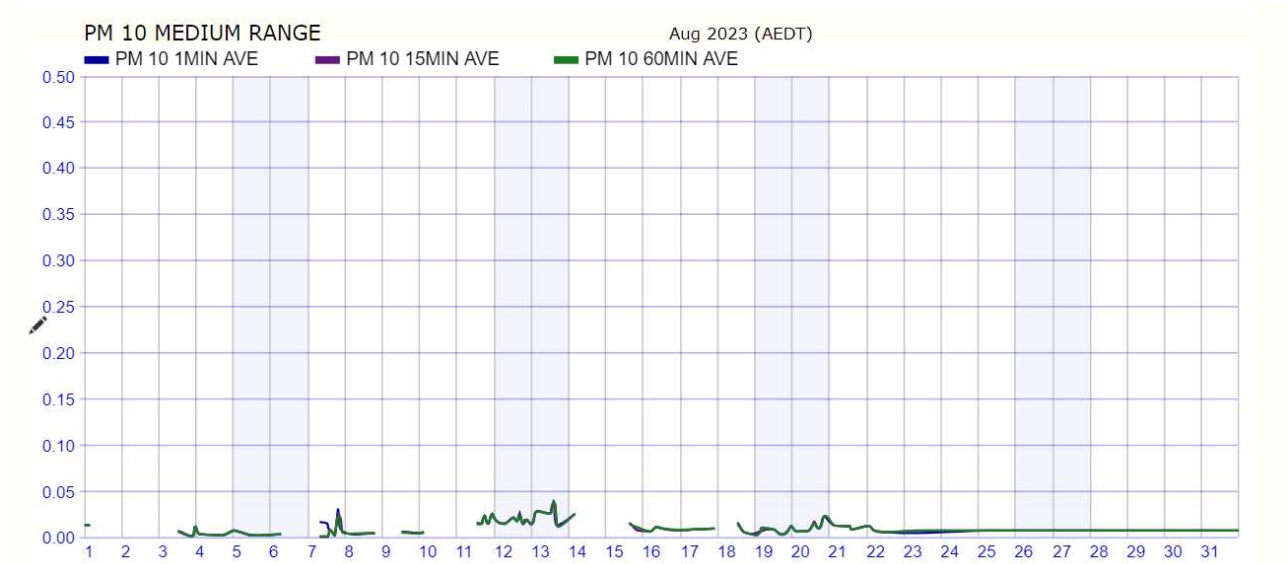
Dust Monitor 005 was observed to be offline sporadically throughout the month of August.

Figure 1. Summary of PM10 from the real time monitoring at location 005 – Solar Industry for the month of August 2023.

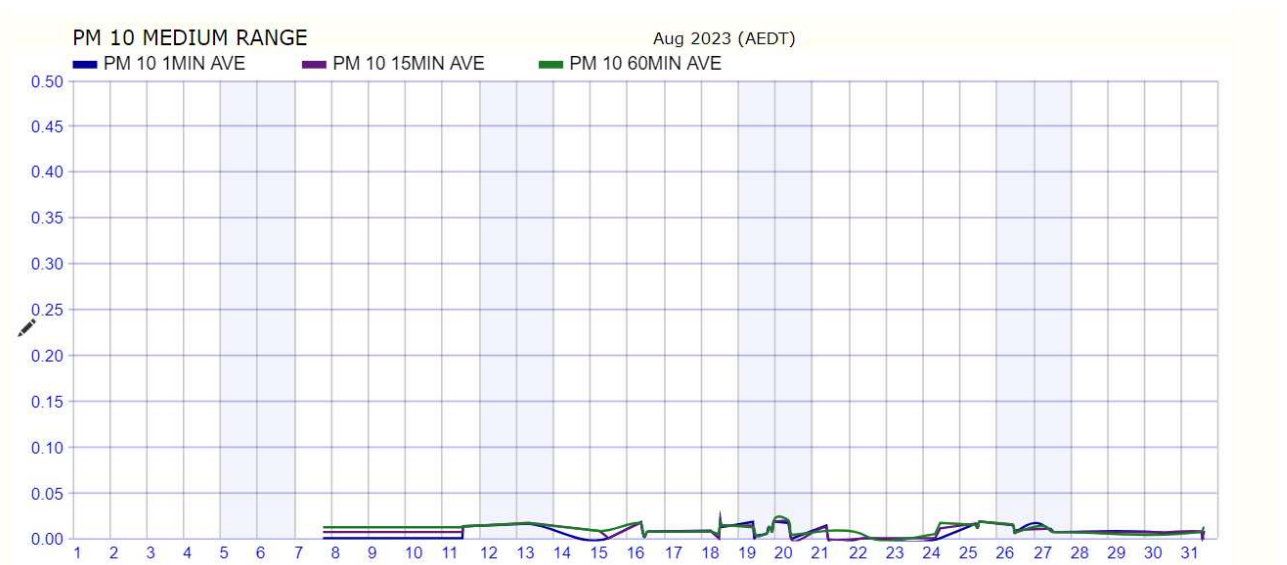
During the reported monitoring period, data was missing from the 1st of the month to the 7th.

Figure 2. Summary of PM10 from the real time monitoring at location 006 – Mate and Matts for the month of August 2023.

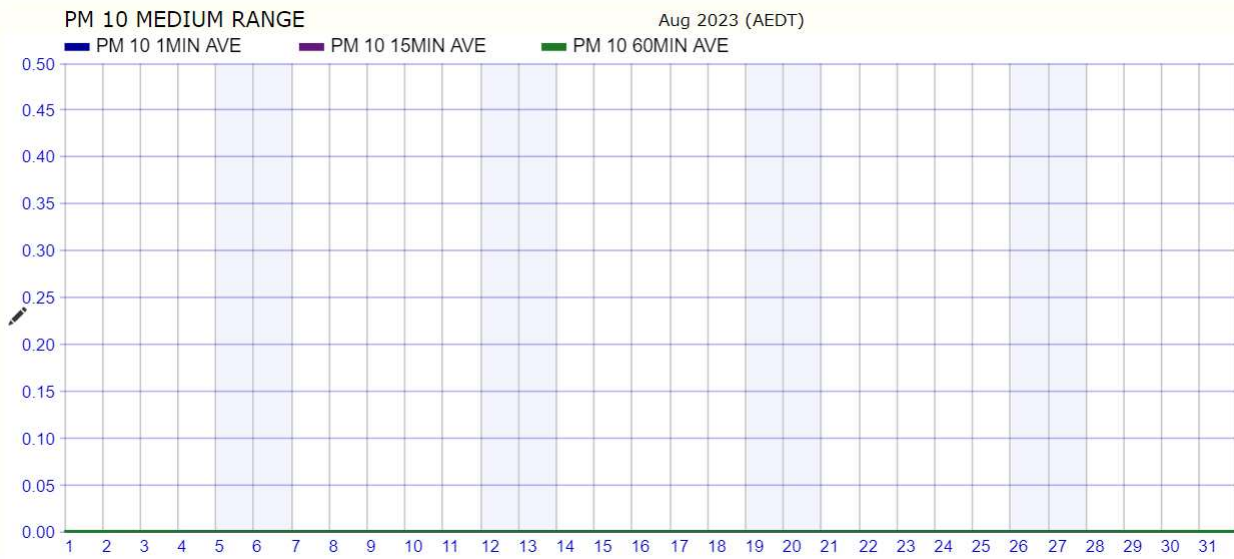
During the reported monitoring period, no data gaps were recorded at Monitoring Location 007. All data from Dust Monitor 007 were correctly collected.

Figure 3. Summary of PM10 from the real time monitoring at location 007 – Residential for the month of August 2023.
