# **Environmental Dust Assessment Report (January 2024)**

**Tweed Valley Hospital Project, Cudgen NSW**

A101021.0286.00 | EDM53.RevF | Date: 7/06/2024

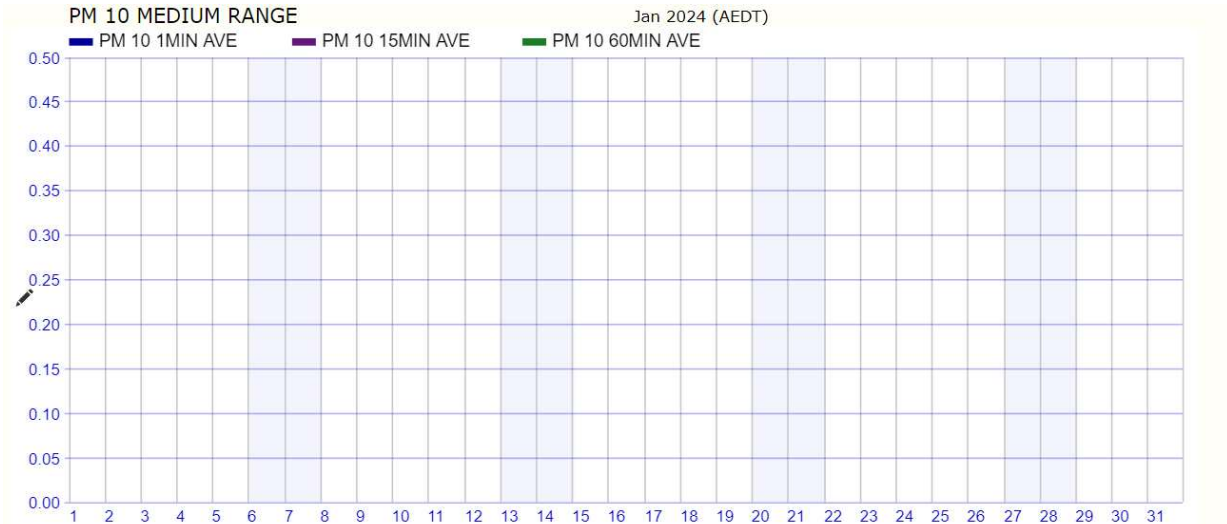
Dust Monitor 005 was observed to be offline throughout January.

**Figure 1.** Summary of PM10 from the real time monitoring at location 005 – Solar Industry for the month of January 2024.

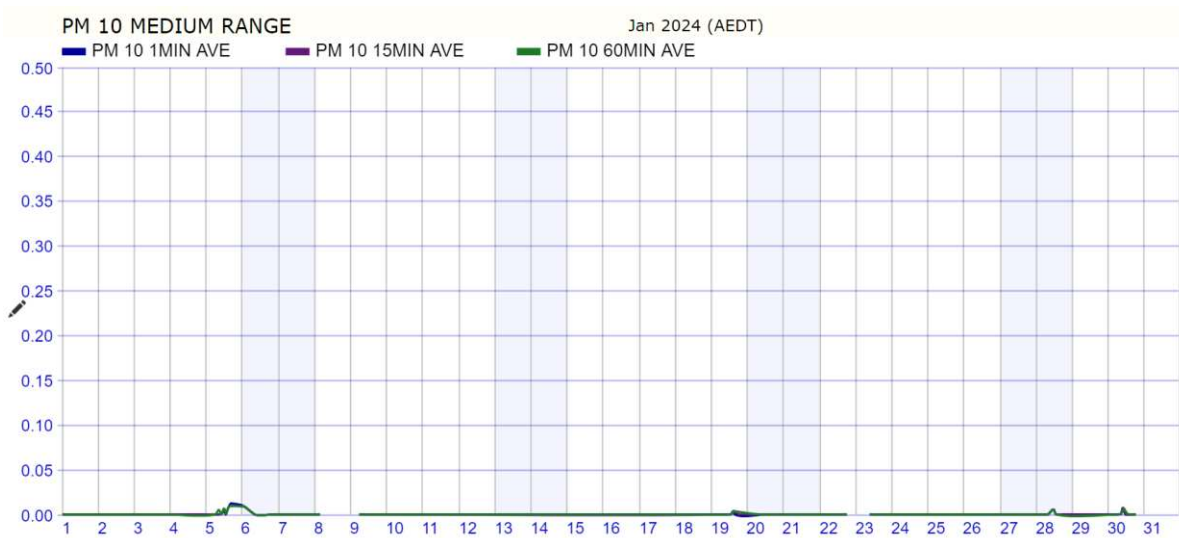
Monitoring location 006 was observed to be functioning sporadically throughout the month of January.

**Figure 2.** Summary of PM10 from the real time monitoring at location 006 – Mate and Matts for the month of January 2024.

All recorded PM<sub>10</sub> dust levels remained below 0.5 mg/m<sup>3</sup> during the month of January 2024 (*refer to Section 3*) at Monitoring Location 006. Recorded data from all monitoring locations were below the Action Limit of 2.5 mg/m<sup>3</sup>. It should be noted that the DustTrak records a minimum concentration reading of 0.001 mg/m<sup>3</sup> and values of lower concentration were recorded as zero.

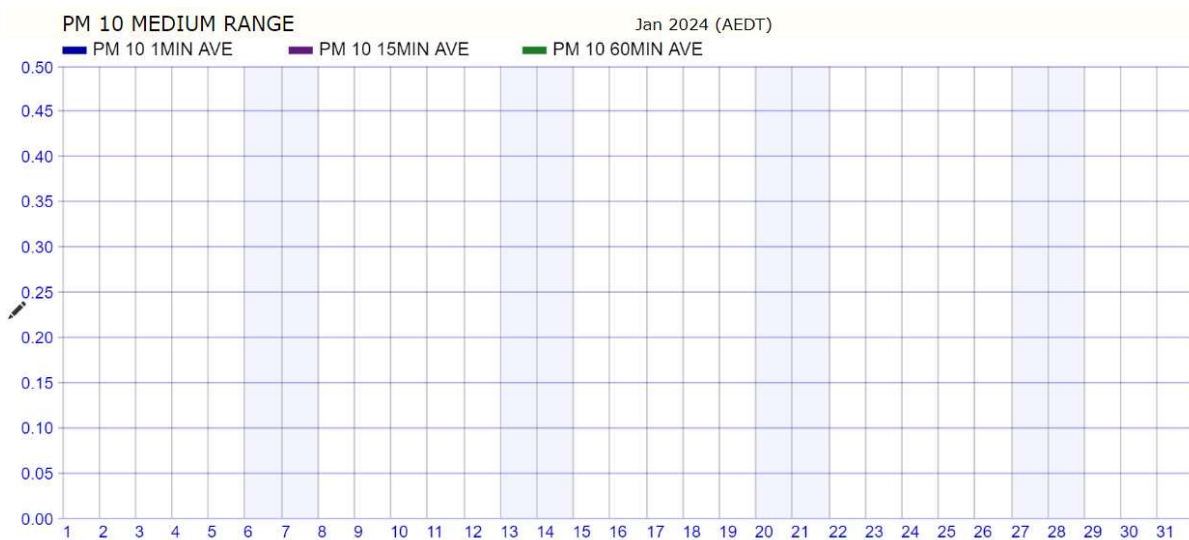
Dust Monitor 005 was observed to be offline throughout January.

**Figure 3.** Summary of PM10 from the real time monitoring at location 007 – Residential for the month of January 2024.

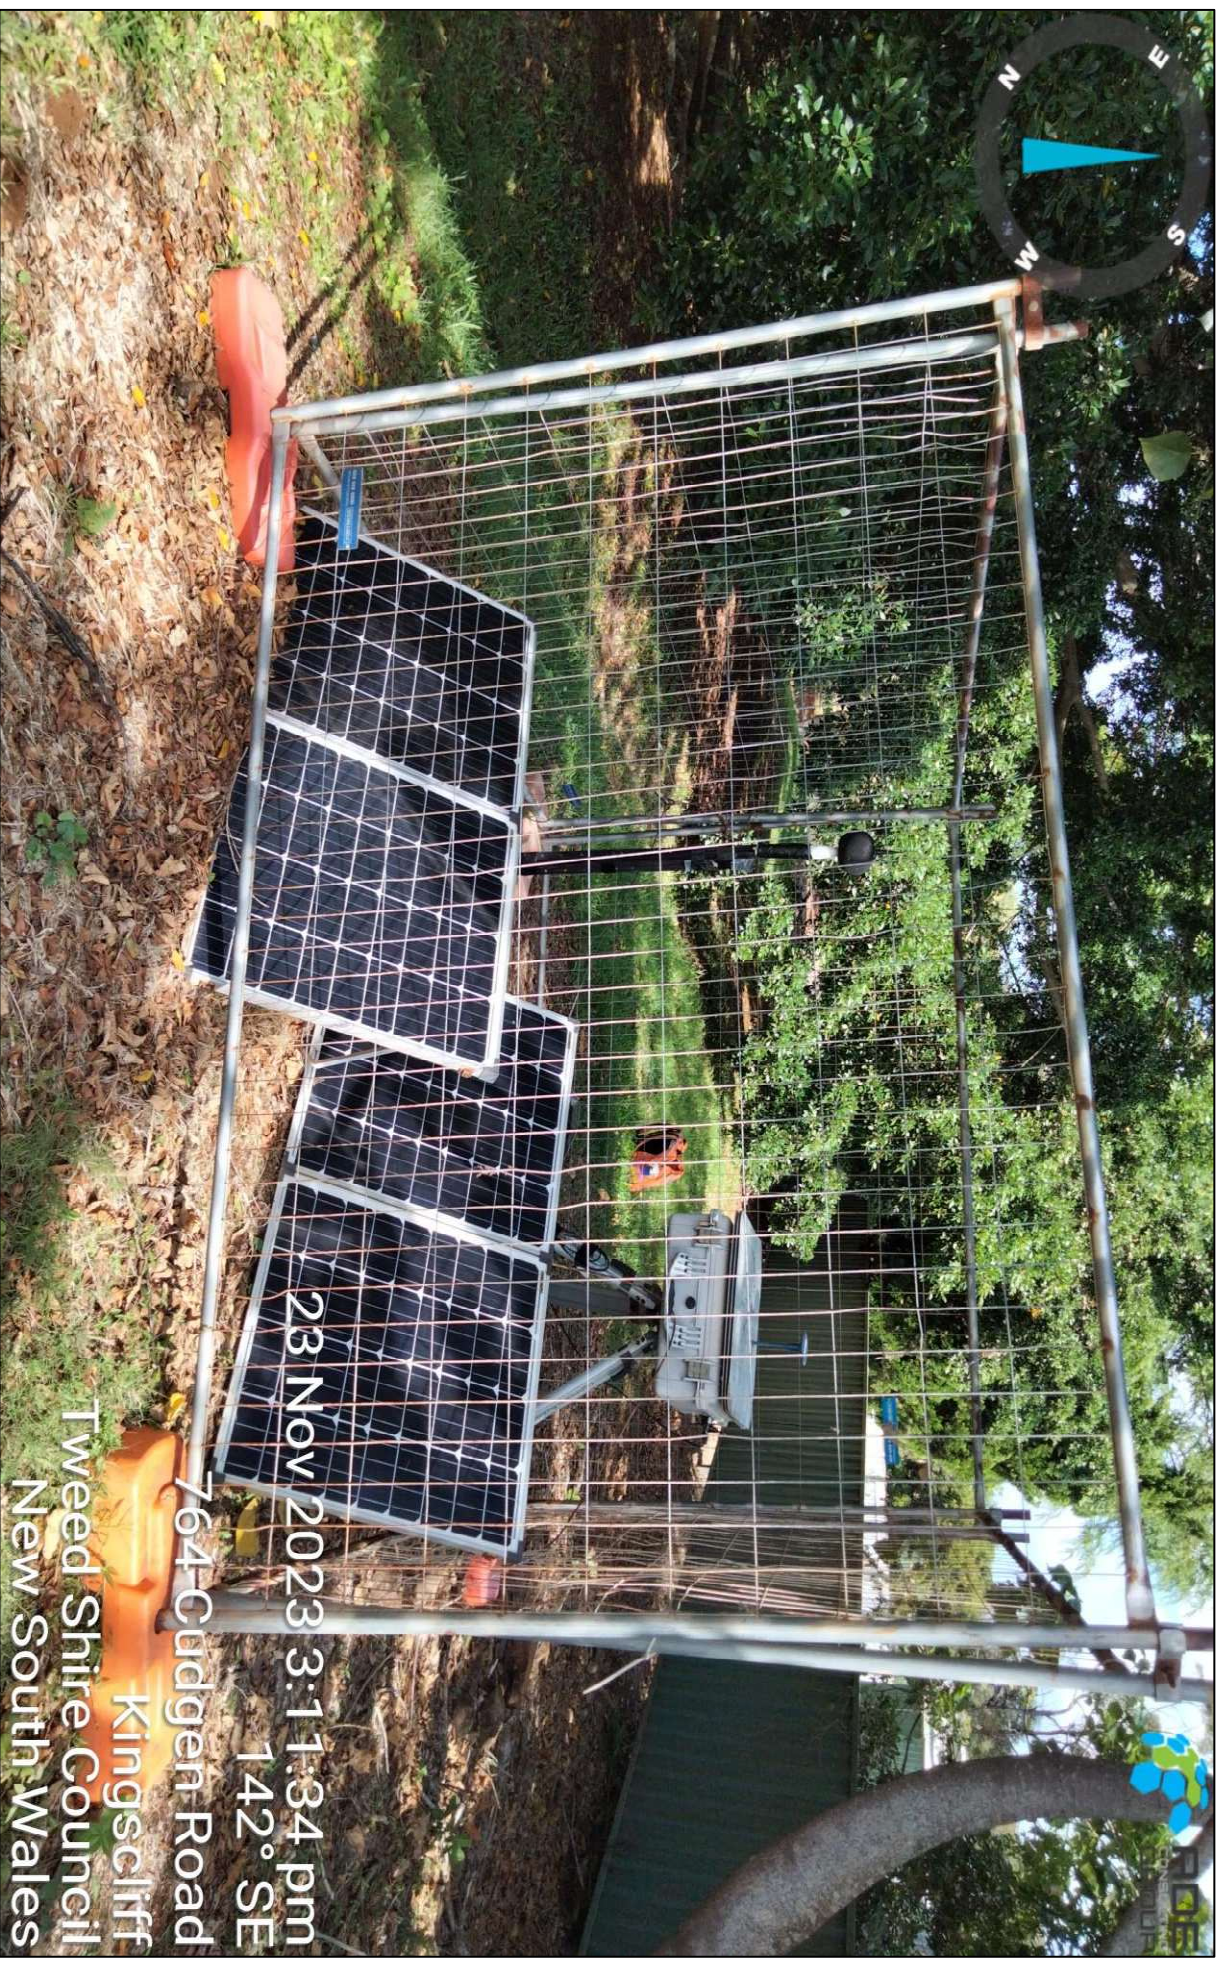
Photograph 1: Representative photograph of monitoring location 005 – Solar Industry, as observed 23/11/2023

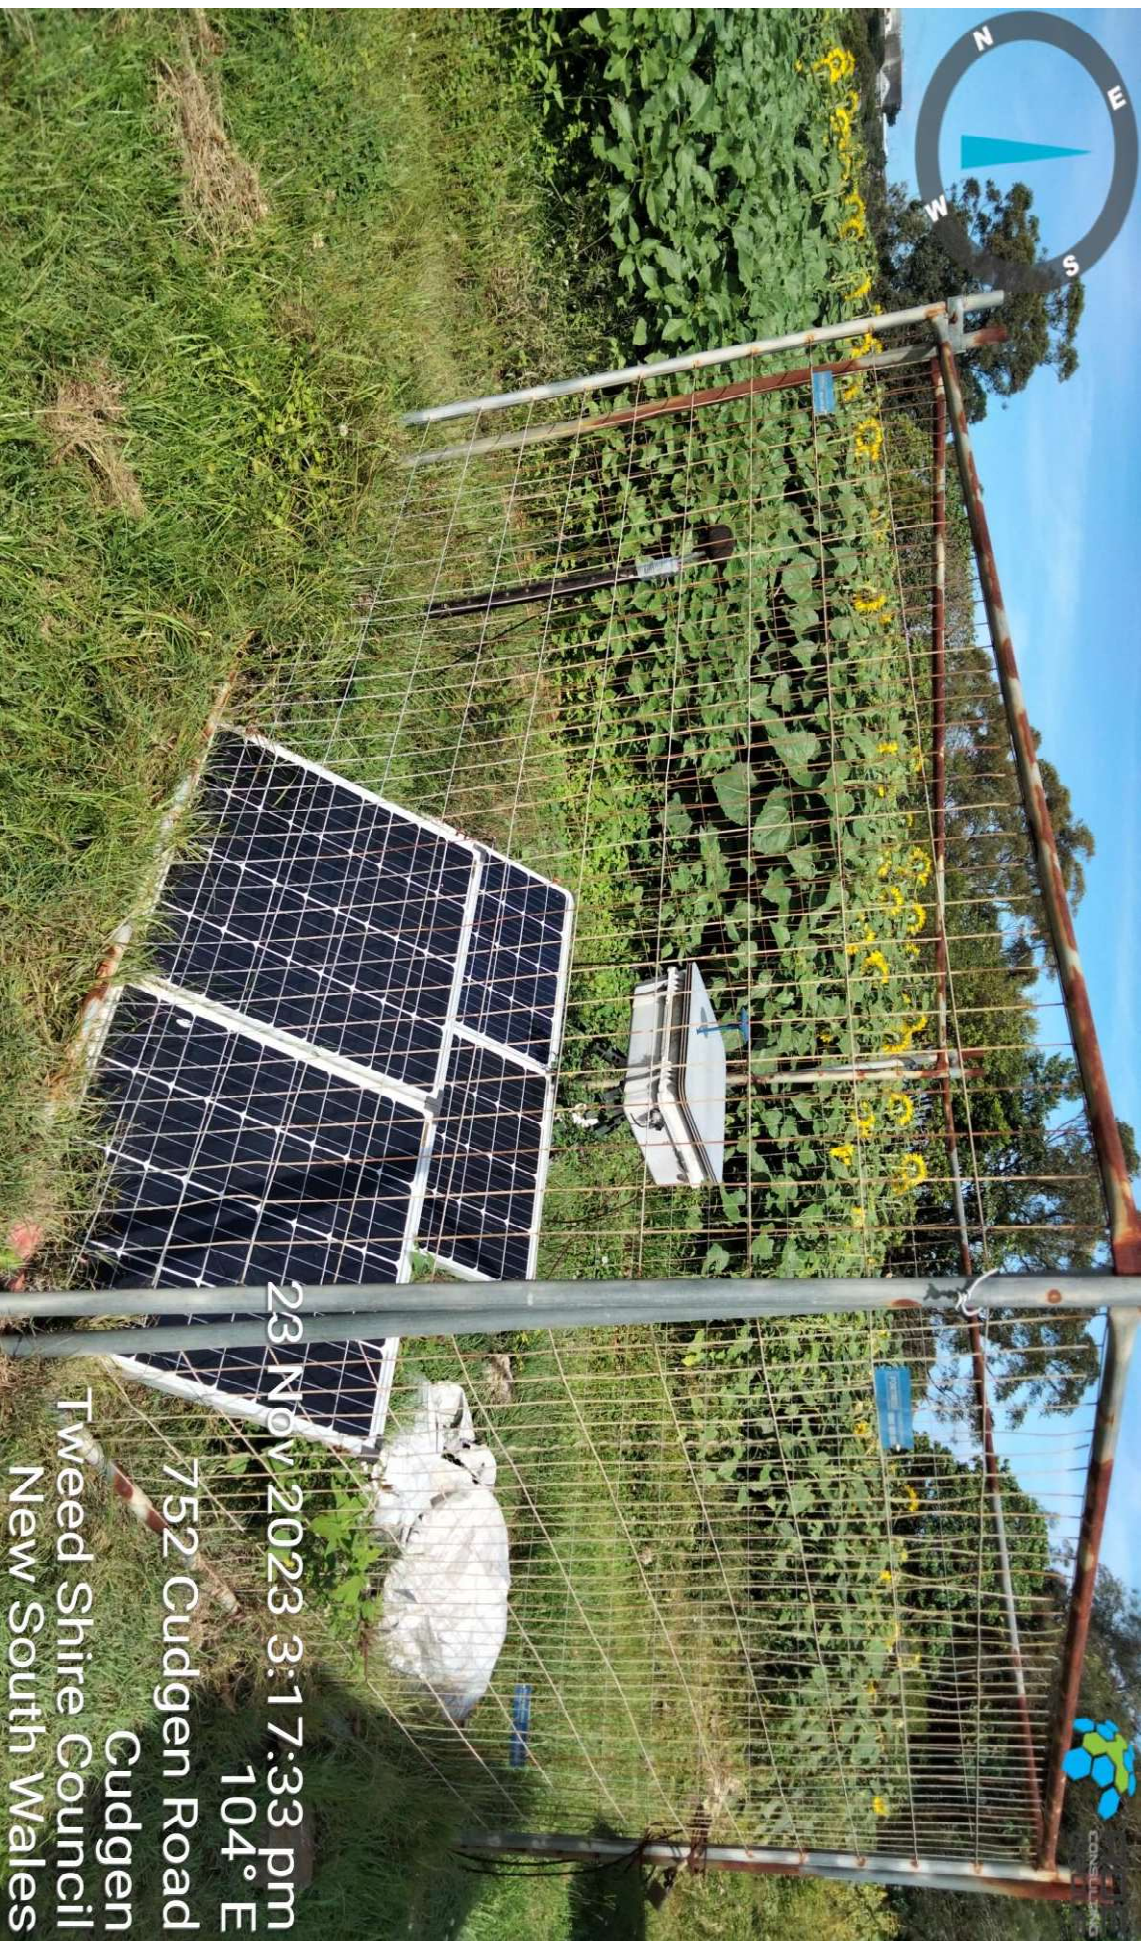
Photograph 2: Representative photograph of monitoring location 006 – Mate and Matts, as observed 23/11/2023

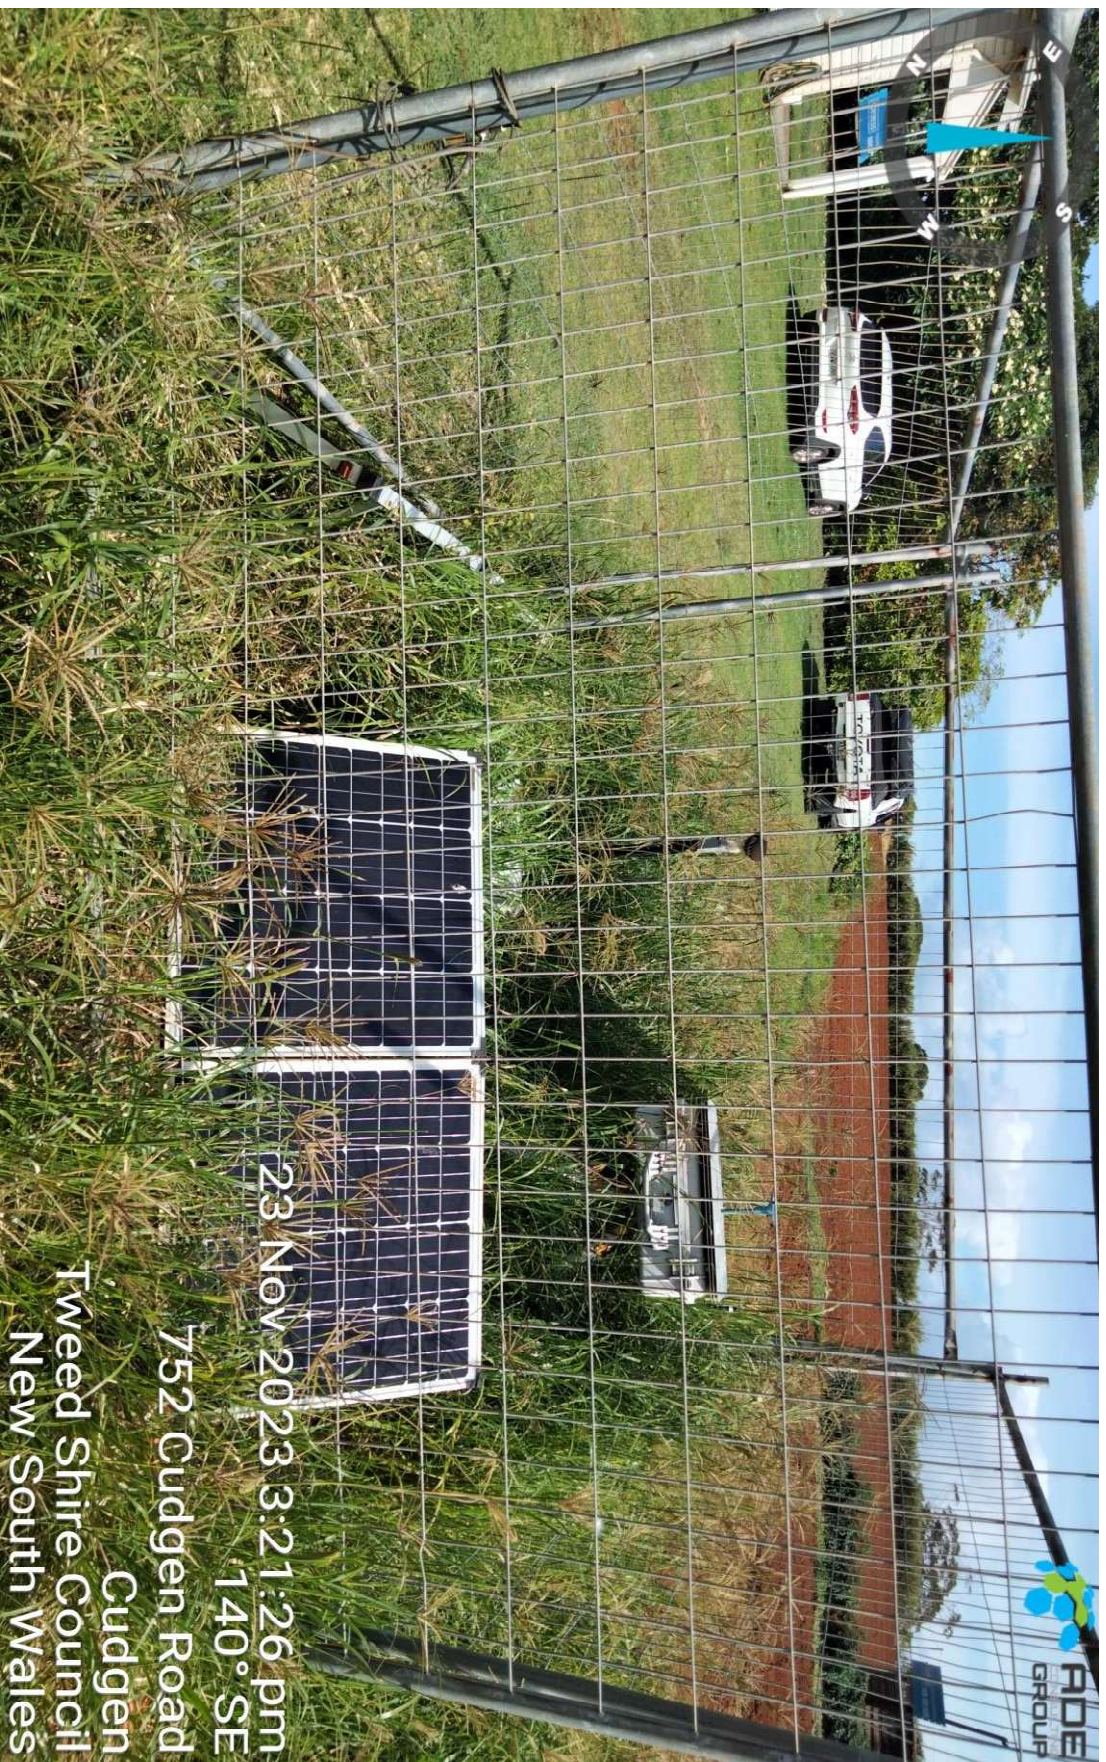
Photograph 3: Representative photograph of monitoring location 007 – Residential, as observed 23/11/2023
