Vibration Monitoring Assessment Report | November 2023

Tweed Valley Hospital 771 Cudgen Road, Cudgen NSW

Prepared for: Lendlease Building Pty Ltd

Job Number: A101021.0286.00 VIB52 v1f | Date: 23/102/2024

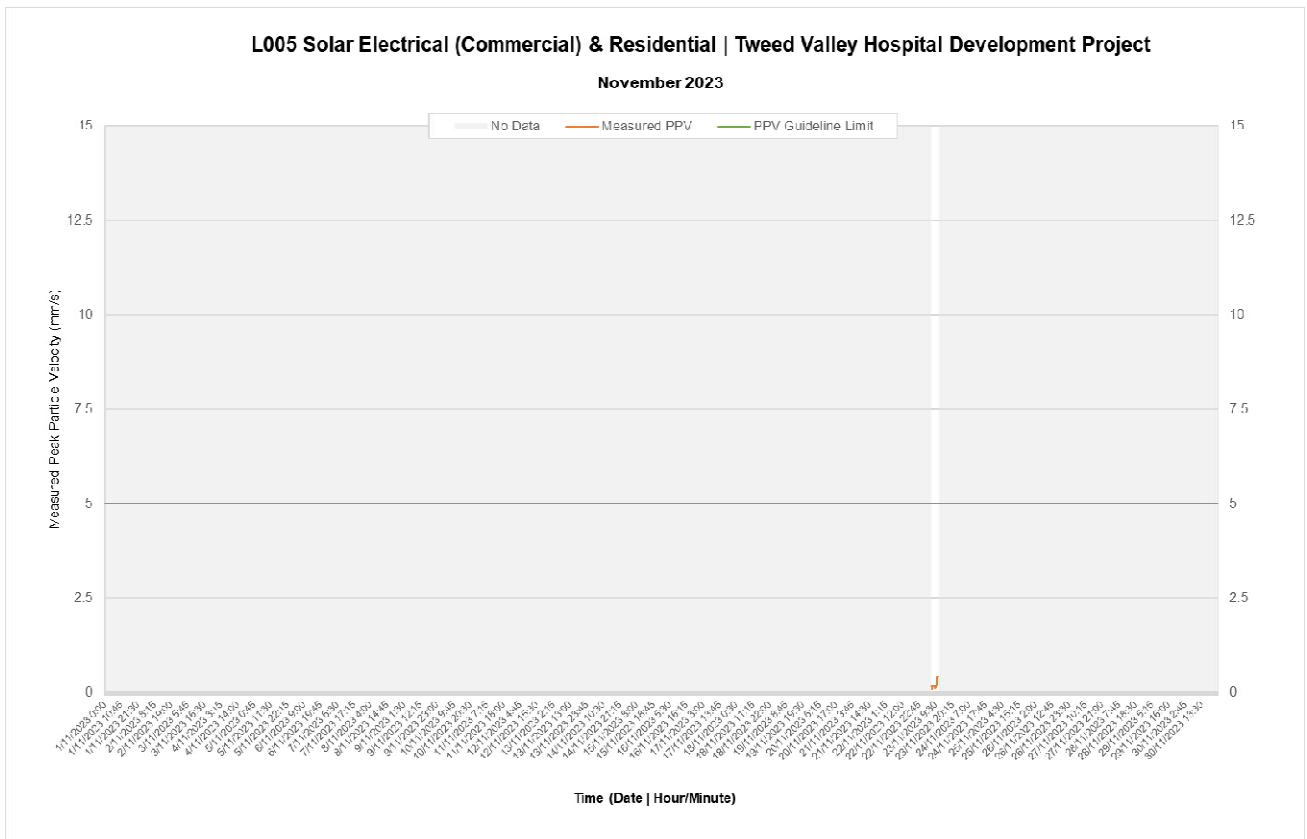
Figure 2 below presents the available velocity (PPV mm/s) at Location L.005 situated by a residential and commercial receiver.

Figure 2 Velocity over time (Logger 005 - Residential/Commercial)

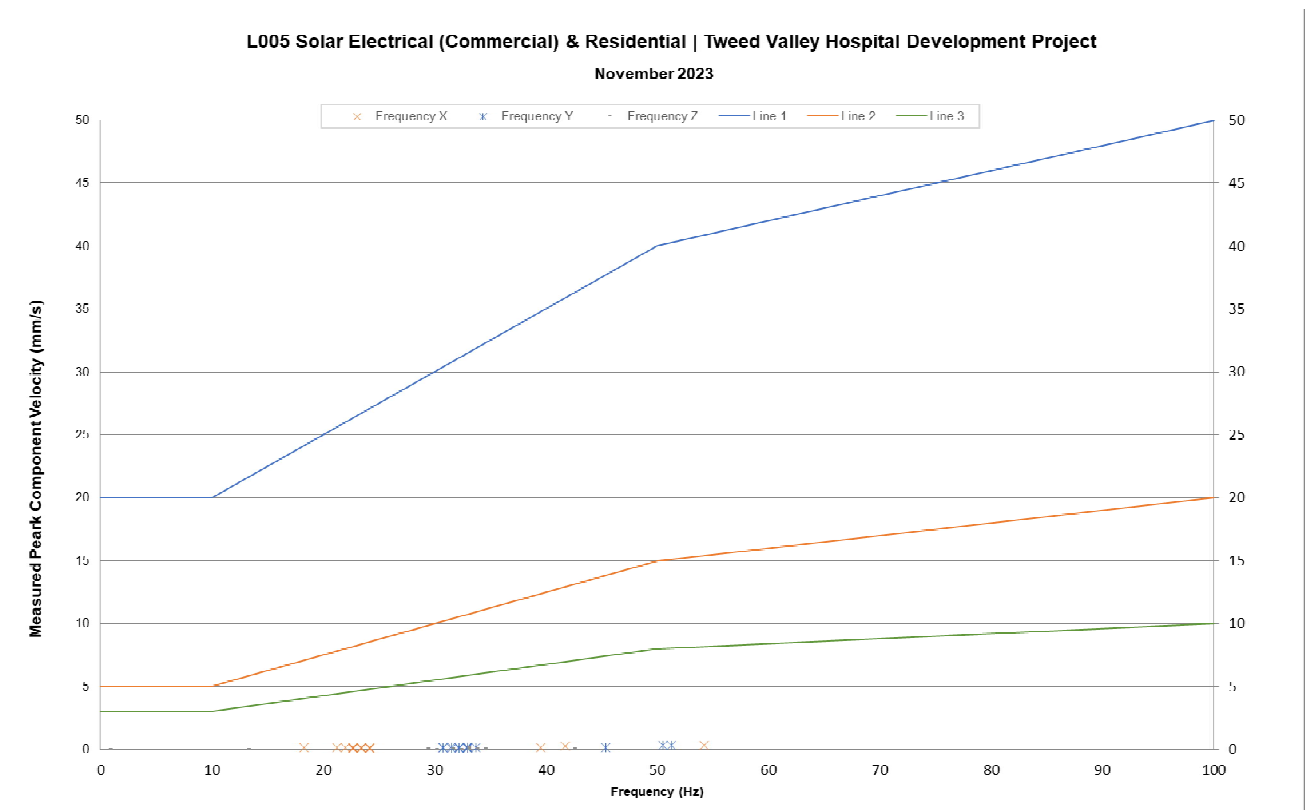
Figure 3 below presents frequency over velocity data for logger L.005.

Figure 3 Frequency over Velocity (Logger 005 – Residential/Commercial)

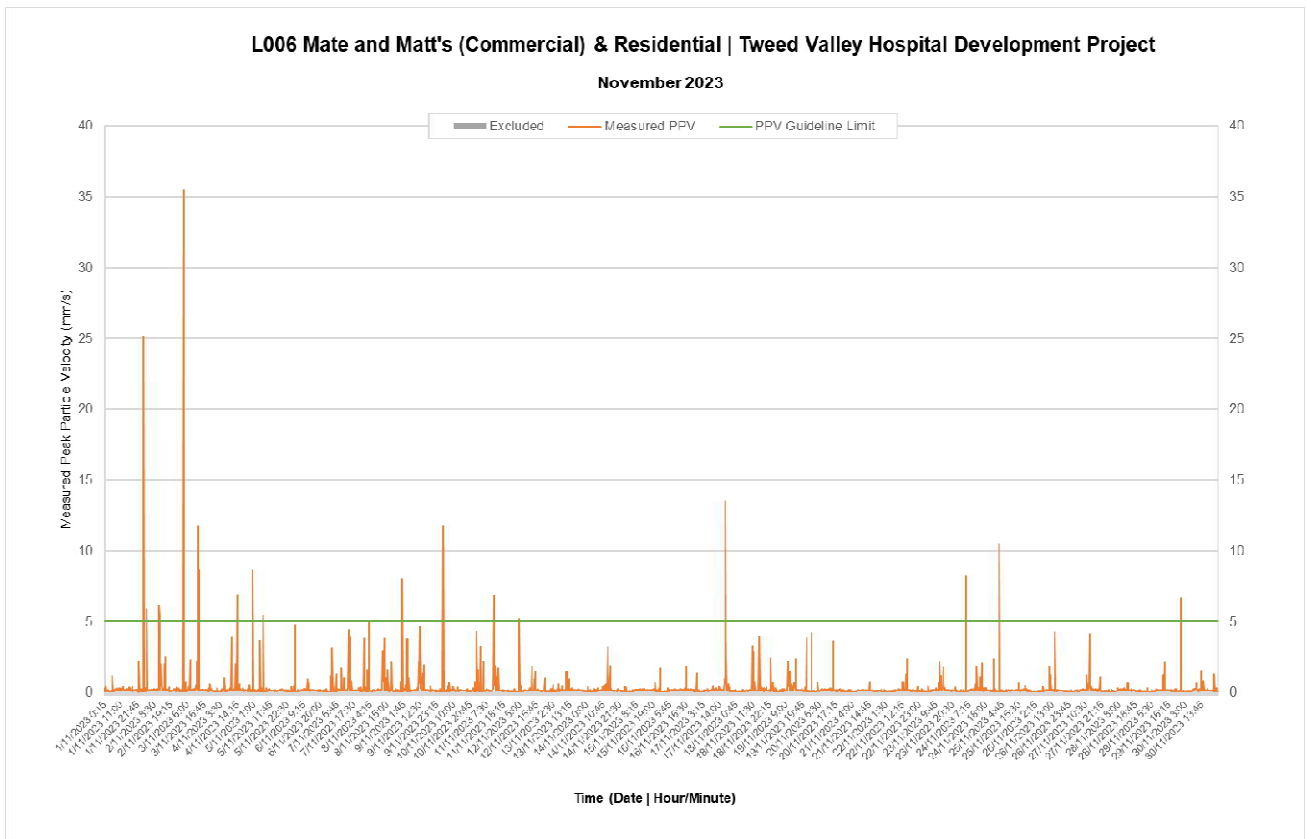
Figure 4 Velocity over time (Logger 006 – Residential/Commercial)

From Figure 4 it can be seen there were numerous exceedances of the velocity guideline recorded during November. This represents a sharp increase on that recorded during October. All measurements are attributed to extraneous activity near the device given most measurements were recorded outside of construction hours or they coincided with ADE staff logger visits.

Regardless, frequency analysis of this demonstrates compliance with the DIN4150 frequency threshold guidelines, hence the measured spike exceeding 5 mm/s is not considered an 'exceedance'.

This location has measured higher vibration activity throughout the course of the loggers' deployment time, attributed to the operation of the business and the area in use by both the Sites contractor and the commercial premises itself.

Site imaging demonstrate that the security cage in use around the logging devices has construction material resting against it, indicating that extraneous activity is present at times, and would contribute to higher readings not considered to be representative of construction activities.

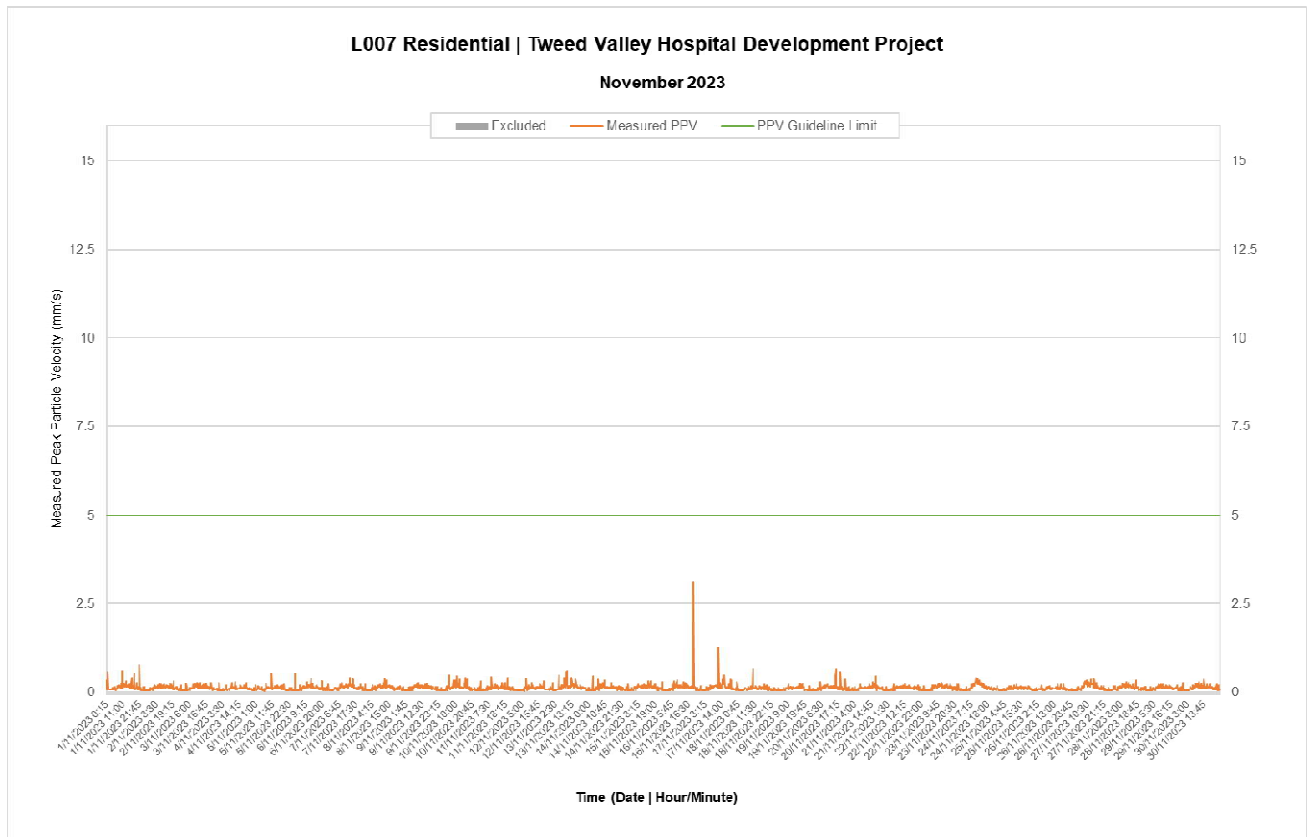
Figure 6 below presents velocity data for the logger located in close proximity to a residential premises, nominated as Location L.007.

Figure 6 Velocity over time (Logger 007 – Residential)

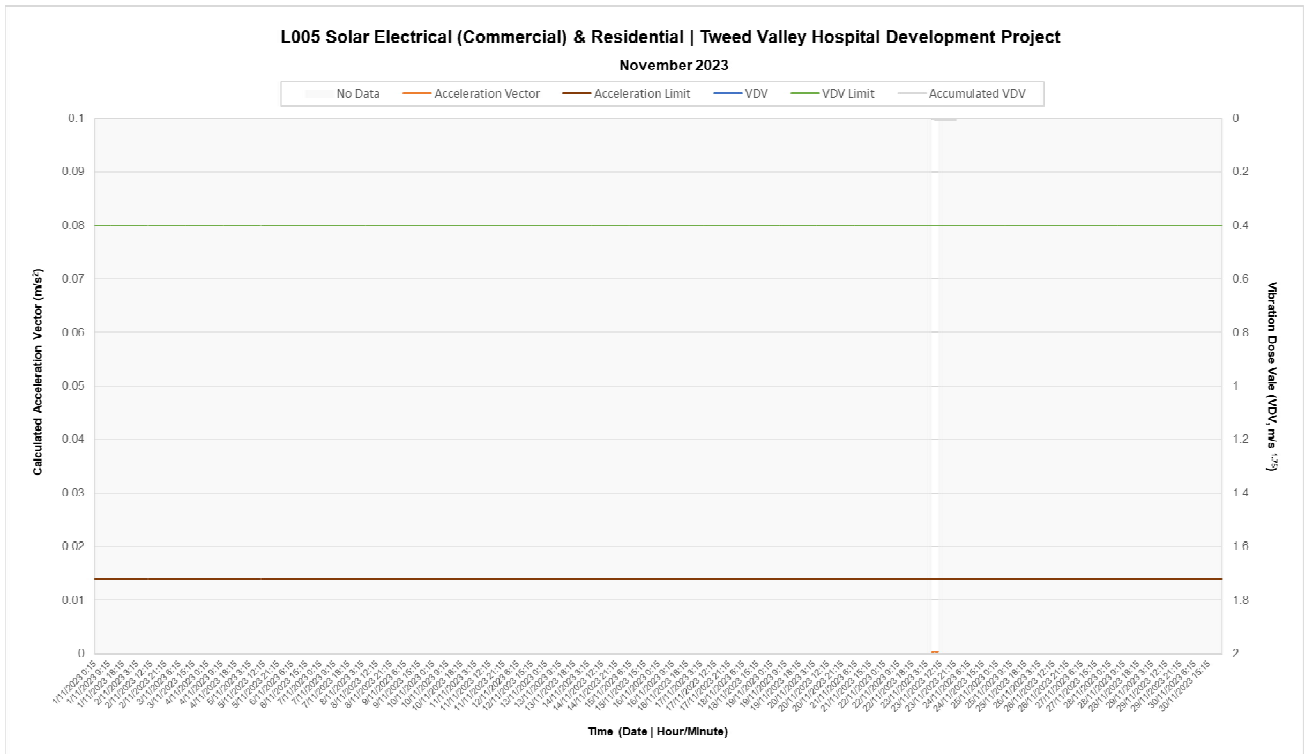
Figure 8 overleaf presents iVDV, accumulated VDV (per period), and weighted RMS Acceleration (α_{rms}) data able to be obtained from L005.

Figure 8 Acceleration and Vibration Dose Value over time (Logger 005)

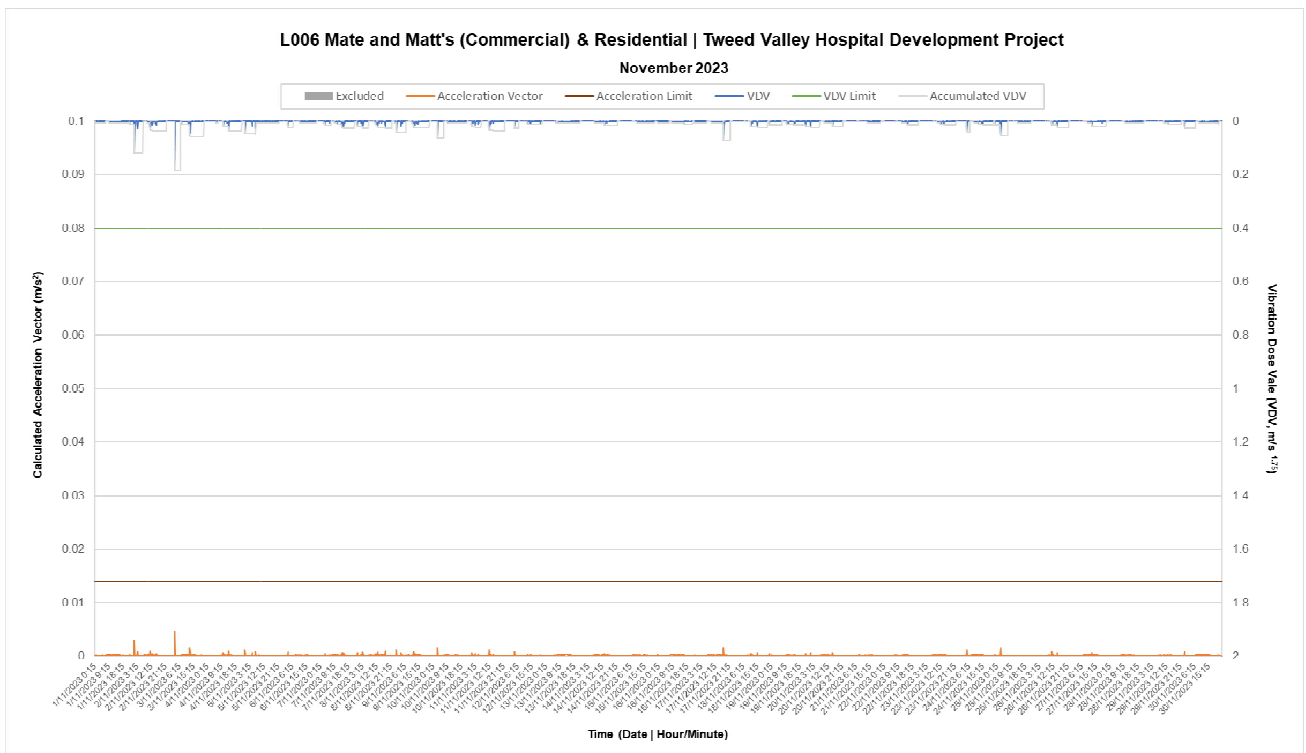
The vibration impact at the commercial and residential premises is presented below in **Figure 9**.

Figure 9 Acceleration and Vibration Dose Value over time (Logger 006 – Residential/Commercial)

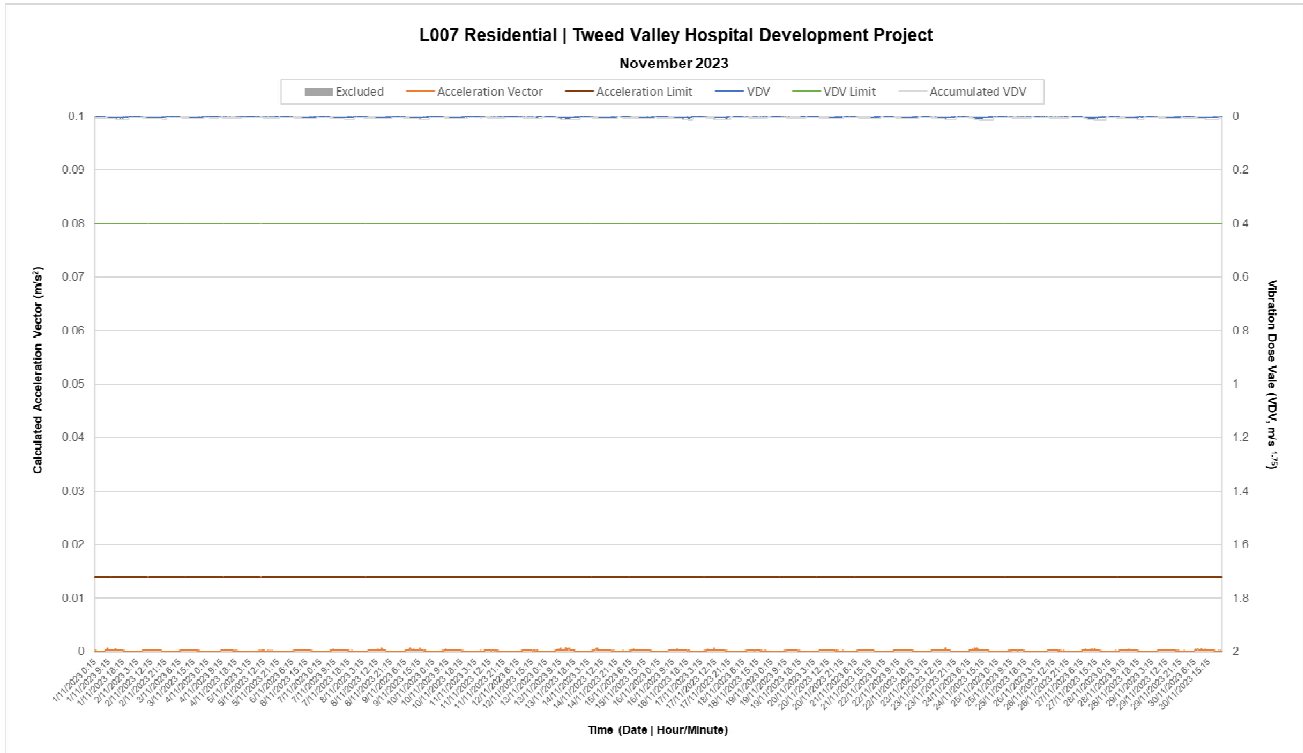
Figure 10 which follows presents vibration dose at the southwestern residential receiver at Location L.007.

Figure 10 Acceleration and Vibration Dose Value over time (Logger 007 – Residential)

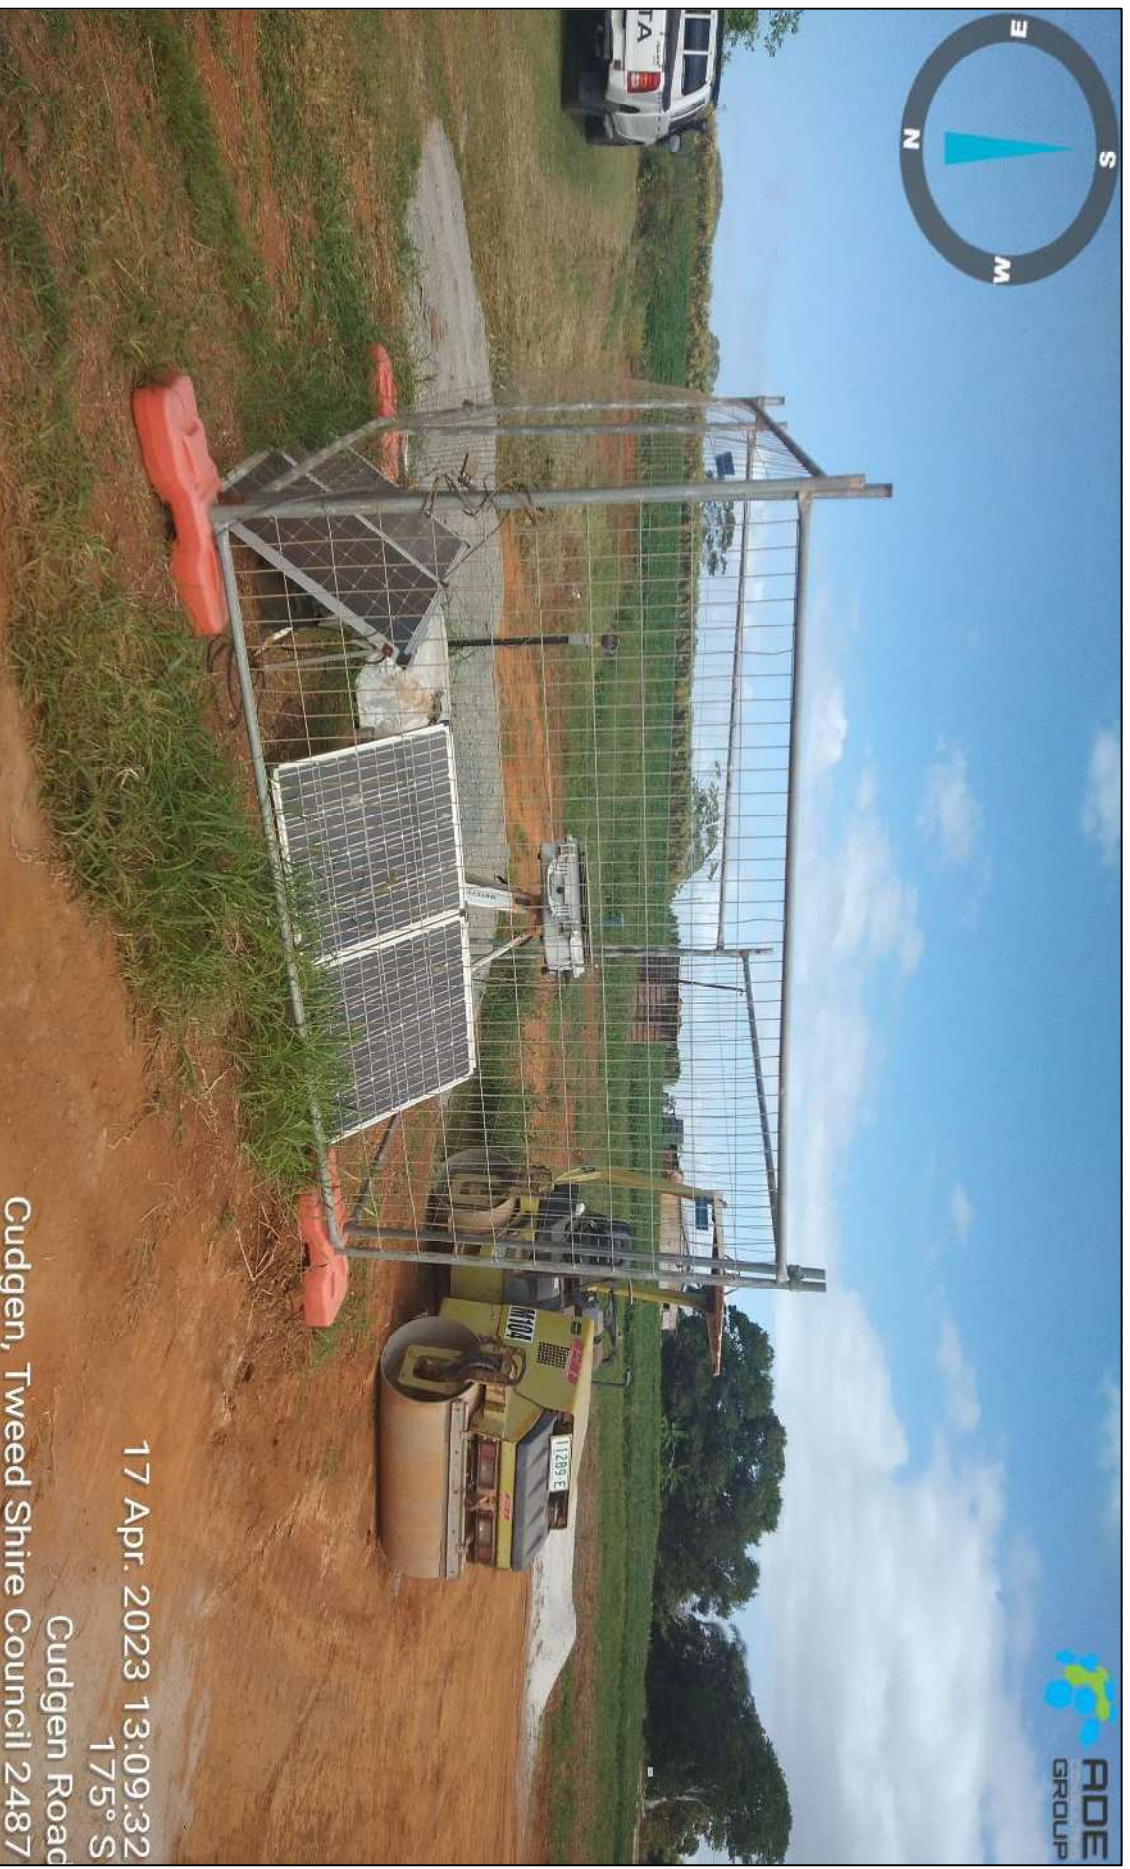
Photograph 1 Representative photograph of monitoring location 007 – Residential, as observed 17/04/2023

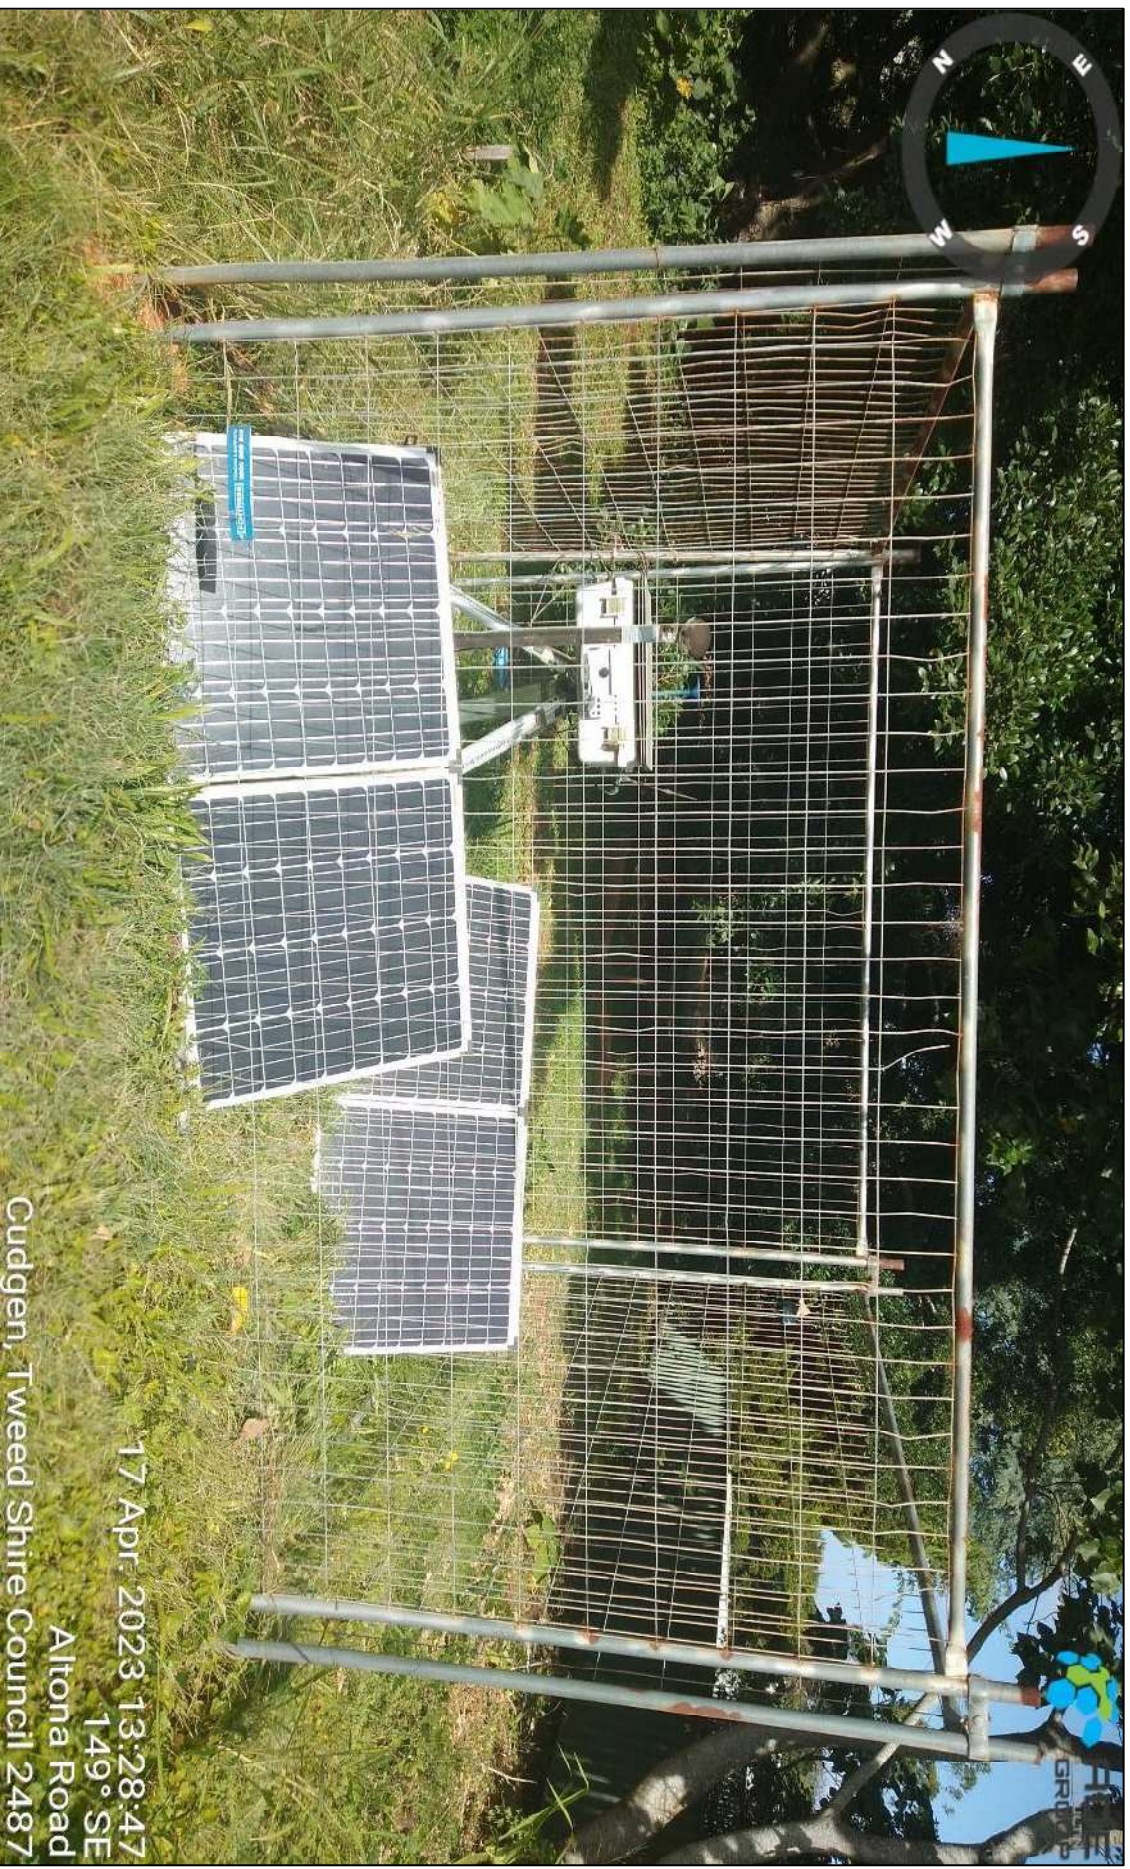
Photograph 2 Representative photograph of monitoring location 005 – Solar Industry, as observed 17/04/2023

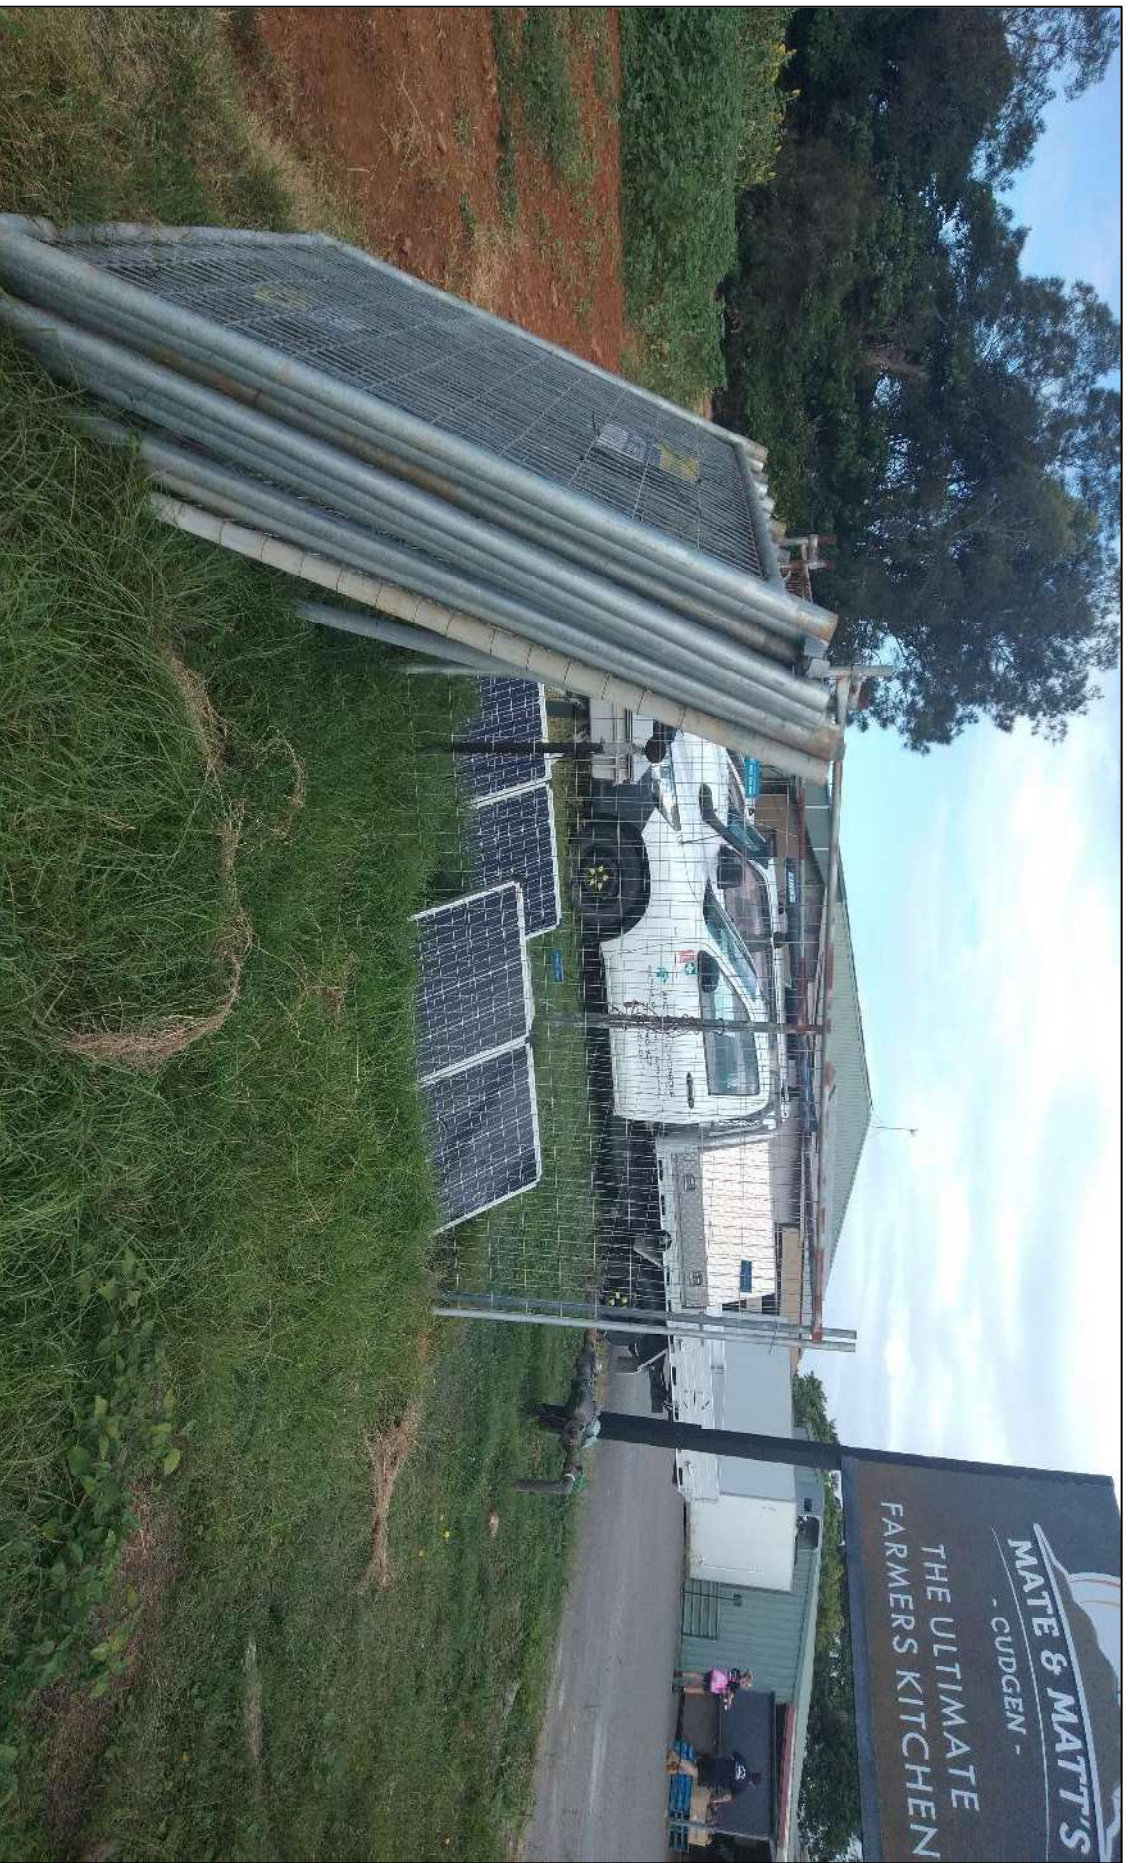
Photograph 3 Representative photograph of monitoring location 006 – Mate and Matts, as observed 17/04/2023
