Environmental Dust Assessment Report (December 2023)

Tweed Valley Hospital Project, Cudgen NSW

A101021.0286.00 | EDM52.RevF | Date: 7/06/2024

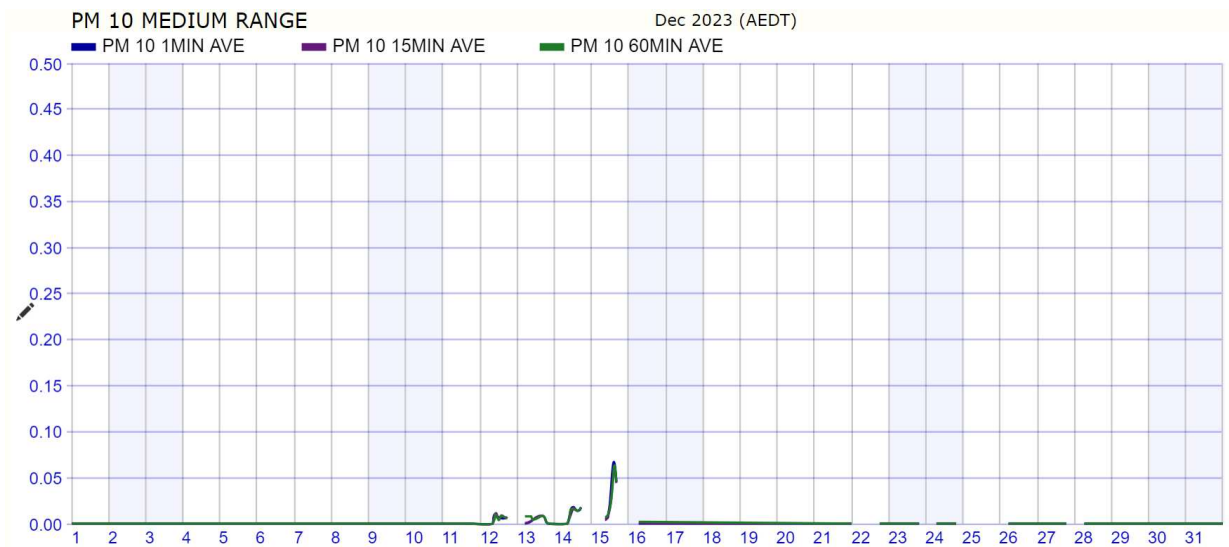
Monitoring location 006 was observed to be sporadically functionally correctly throughout the month of December.

Figure 2. Summary of PM10 from the real time monitoring at location 006 – Mate and Matts for the month of December 2023.

All recorded PM₁₀ dust levels remained below 0.5 mg/m³ during the month of December 2023 (*refer to Section 3*) at Monitoring Location 006. Recorded data from all monitoring locations were below the Action Limit of 2.5 mg/m³. It should be noted that the DustTrak records a minimum concentration reading of 0.001 mg/m³ and values of lower concentration were recorded as zero.

Consistent with previous reports, recommendations are to ensure adequate dust control measures continue to be implemented as per the Tweed Valley Hospital Management Plan – Air Quality and continue monitoring PM₁₀ for the duration of the project. If the action limit of 2.5 mg/m³ (8-hour time weighted average) is exceeded, it is recommended that works are to cease and appropriate dust prevention techniques are to be identified and implemented. To reduce the likelihood of data gaps, daily on-site visual checks are to be undertaken by Lendlease accompanied by daily checks of the online telemetry by ADE.

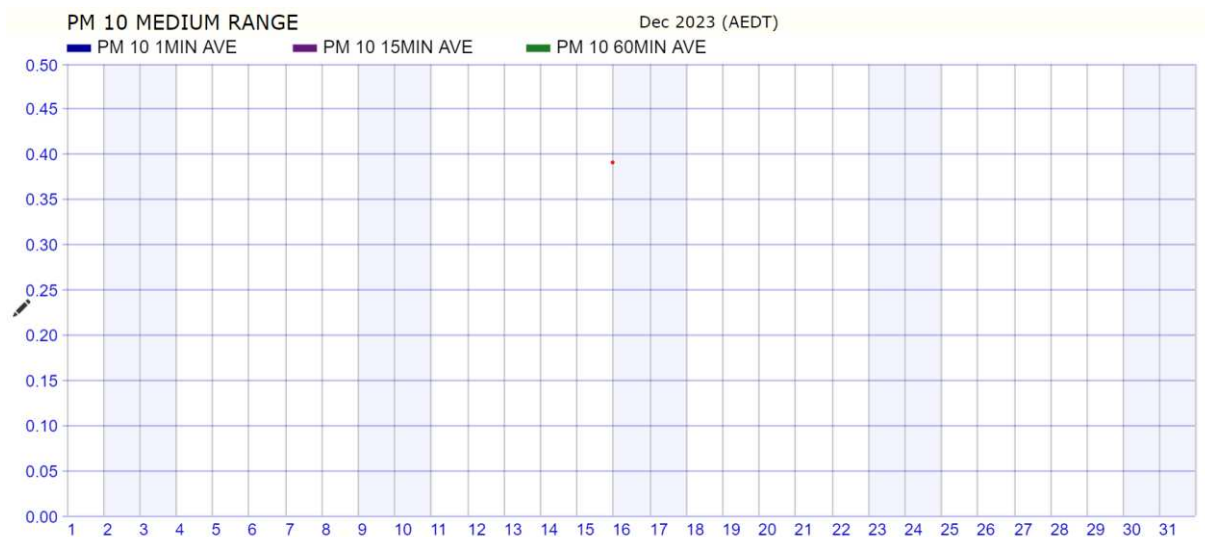
Dust Monitor 005 was observed to be offline throughout December.

Figure 3. Summary of PM10 from the real time monitoring at location 007 – Residential for the month of December 2023.

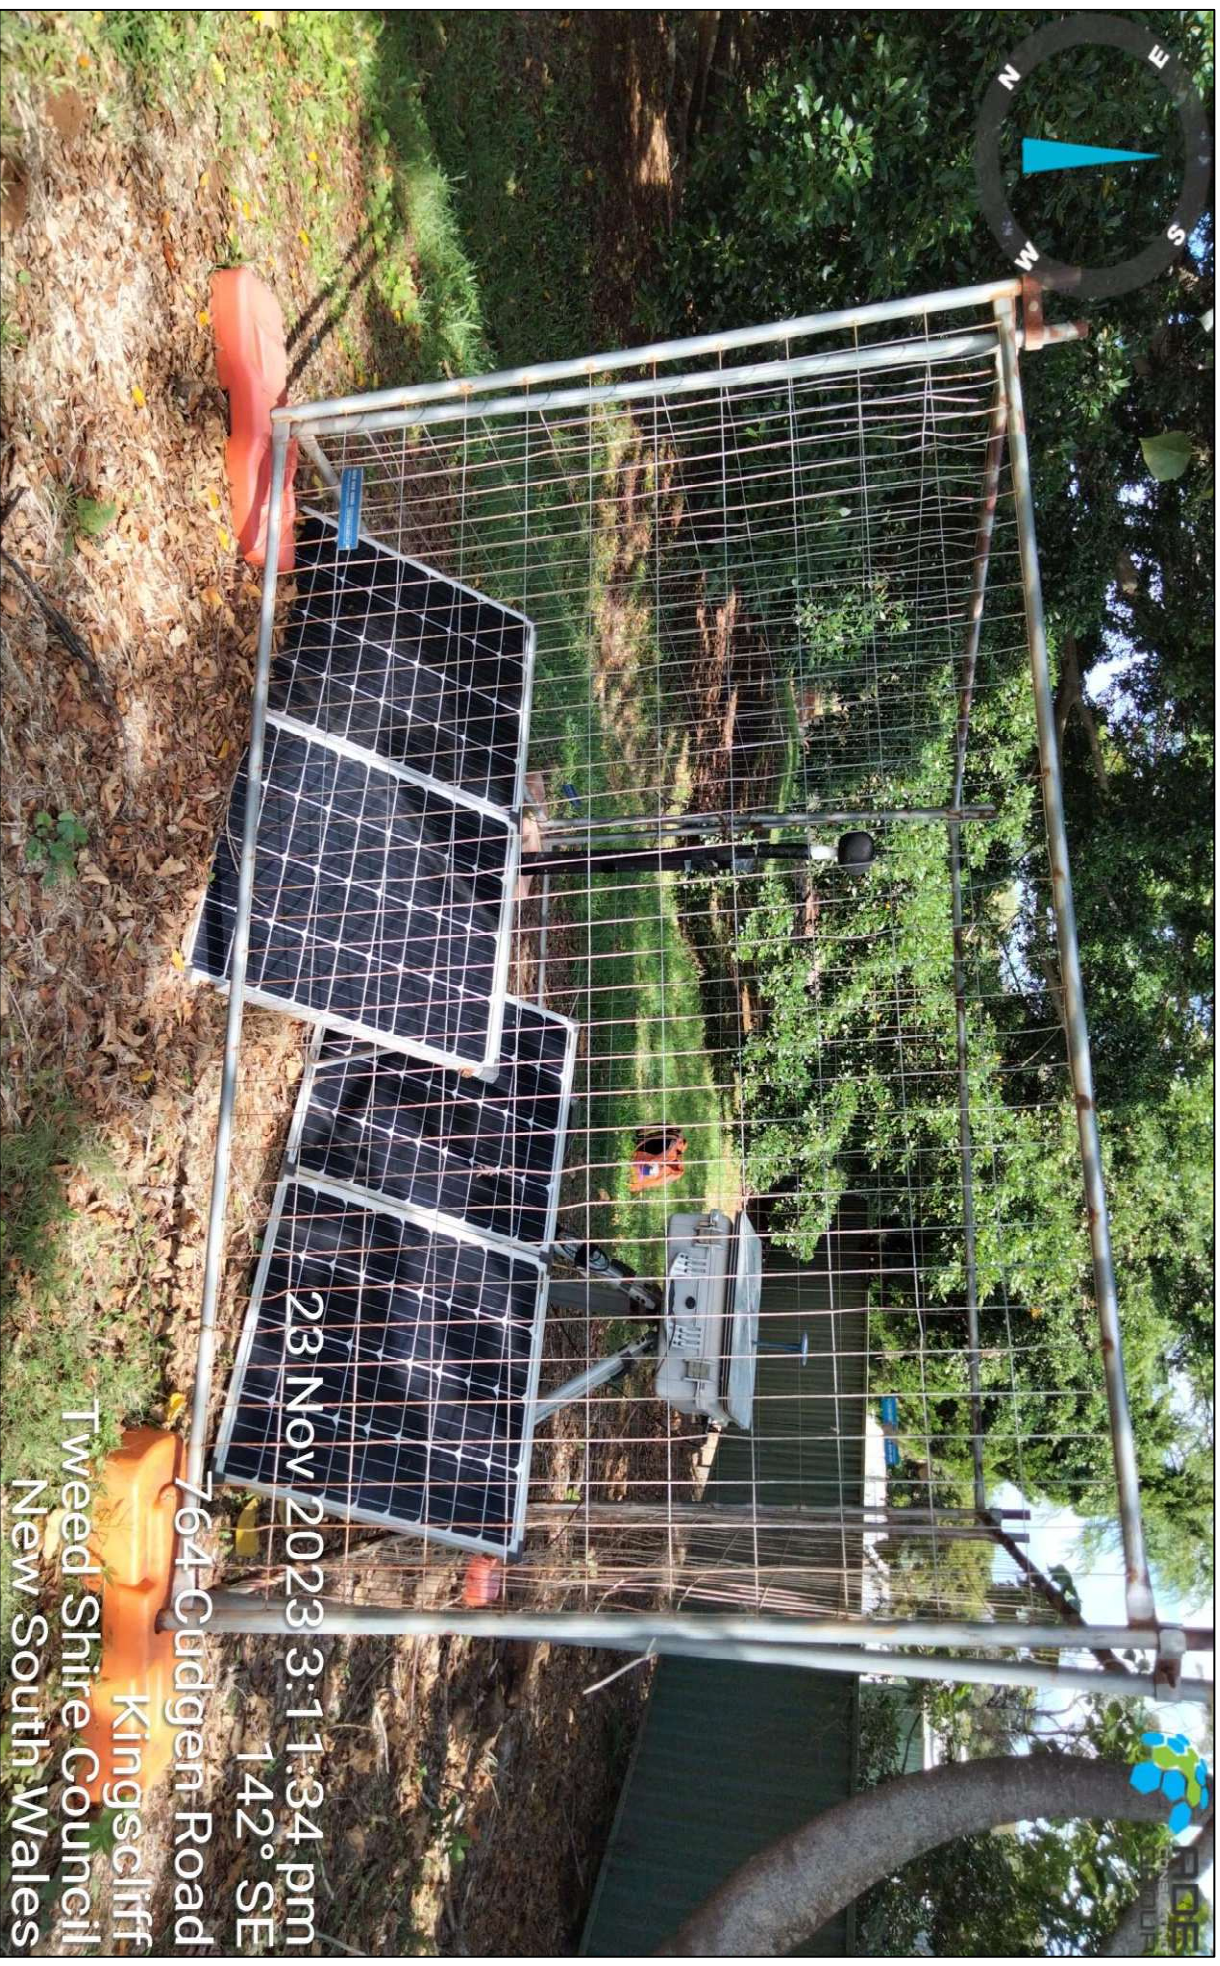
Photograph 1: Representative photograph of monitoring location 005 – Solar Industry, as observed 23/11/2023

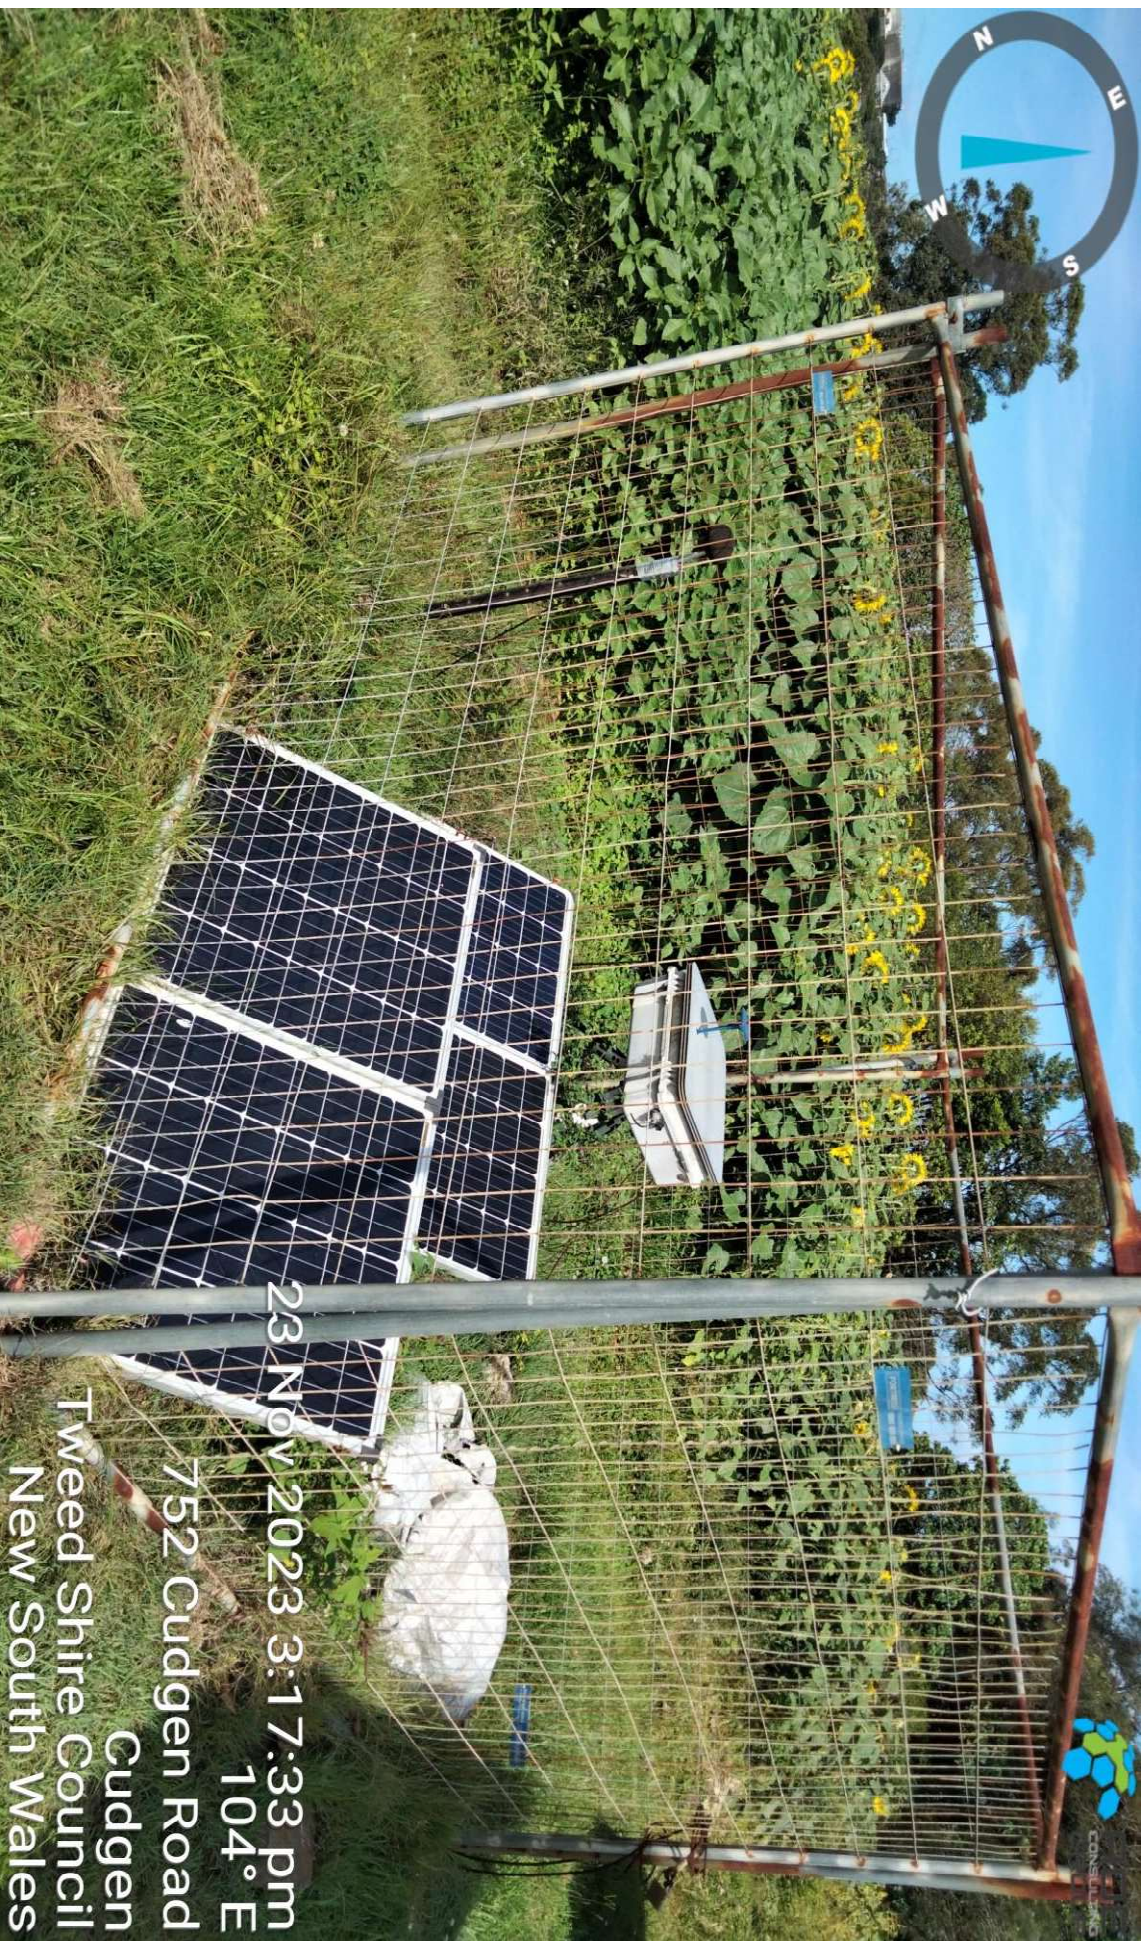
Photograph 2: Representative photograph of monitoring location 006 – Mate and Matts, as observed 23/11/2023
