# Vibration Monitoring Assessment Report | December 2023

**Tweed Valley Hospital 771 Cudgen Road, Cudgen NSW**

Prepared for: Lendlease Building Pty Ltd

Job Number: A101021.0286.00 VIB53 v1f | Date: 25/102/2024

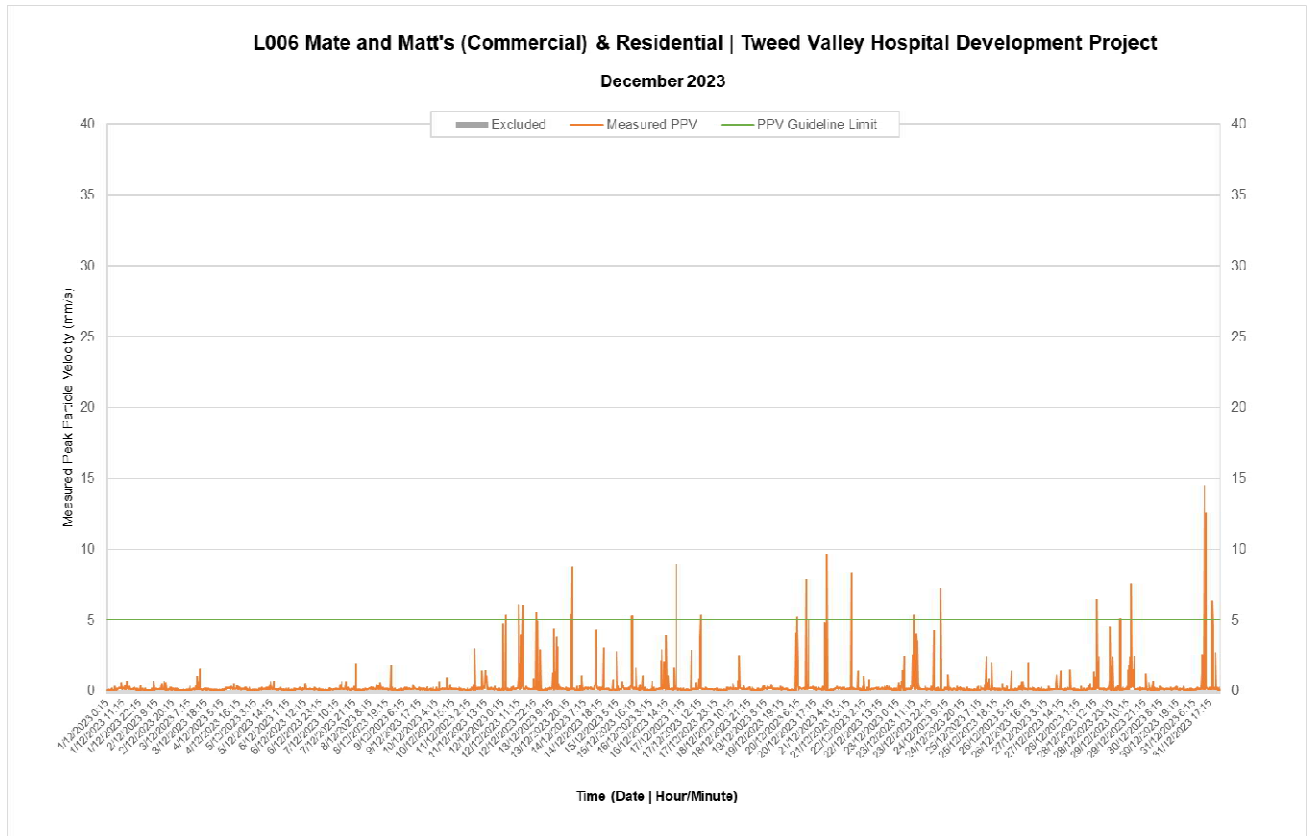
**Figure 2** below presents velocity data for the logger located to a commercial and residential premises ('Mate and Matt's') nominated as Location L.006.

**Figure 2** Velocity over time (Logger 006 – Residential/Commercial)

From **Figure 2** it can be seen there were numerous exceedances of the velocity guideline recorded during December. This represents a minor decrease on that recorded during October. All measurements are attributed to extraneous activity near the device given most measurements were recorded outside of construction hours or they coincided with ADE staff logger visits.

Regardless, frequency analysis of this demonstrates compliance with the DIN4150 frequency threshold guidelines, hence the measured spike exceeding 5 mm/s is not considered an 'exceedance'.

This location has measured higher vibration activity throughout the course of the loggers' deployment time, attributed to the operation of the business and the area in use by both the Sites contractor and the commercial premises itself.

Site imaging demonstrate that the security cage in use around the logging devices has construction material resting against it, indicating that extraneous activity is present at times, and would contribute to higher readings not considered to be representative of construction activities.

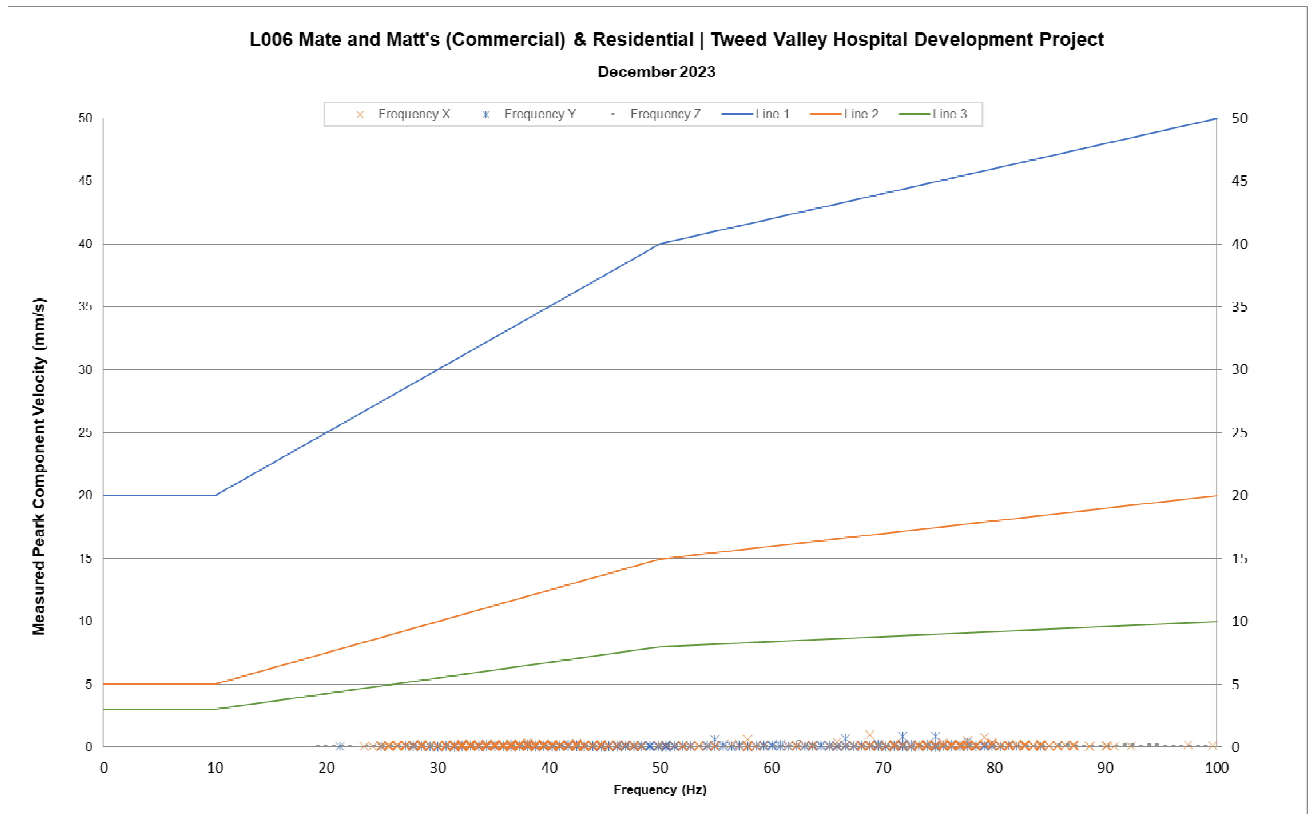
Figure 3 below illustrates the frequency over the velocity for each axis at Location L.006.

Figure 3 Frequency over Velocity (Logger 006 – Residential/Commercial)

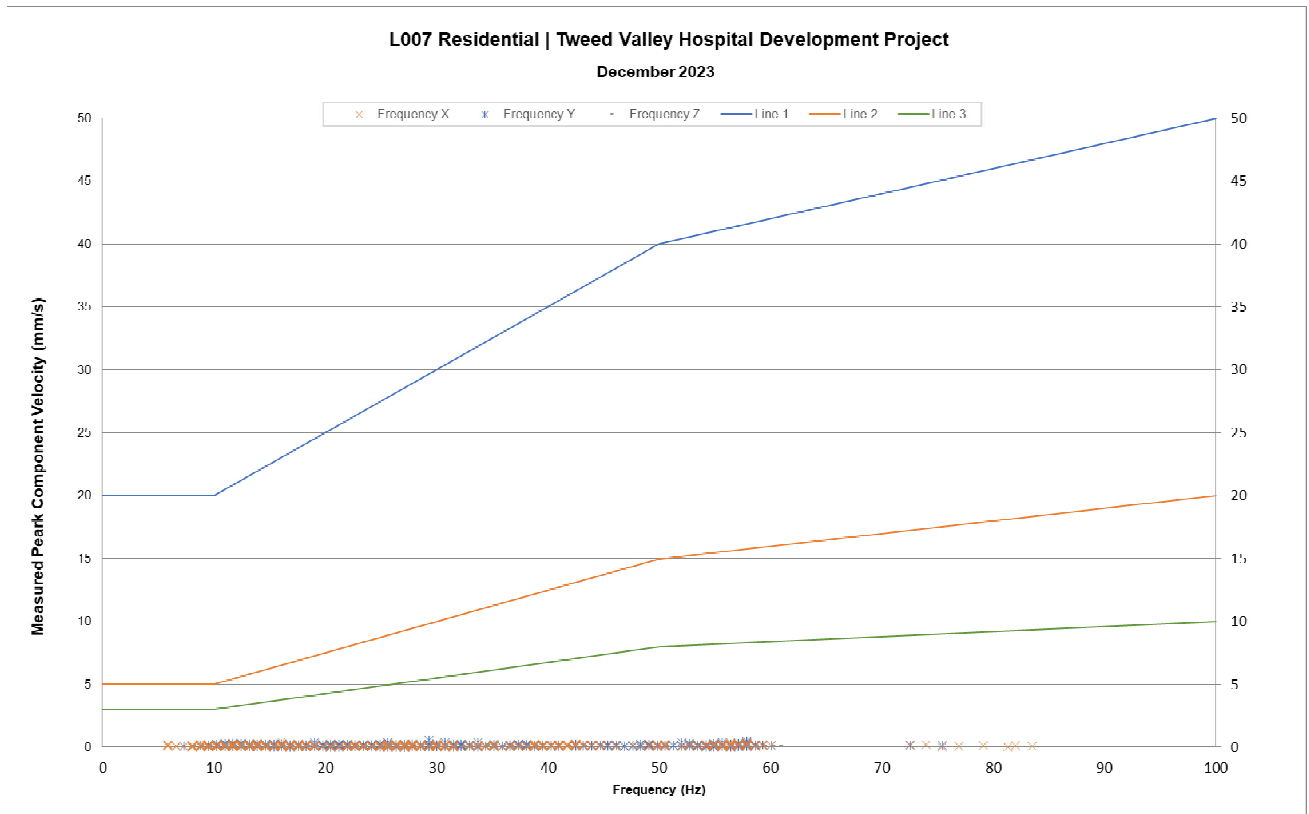
Figure 5 illustrates the Frequency over Velocity for the data collected and analysed at Location L.007.

Figure 5 Frequency over Velocity (Logger 007 – Residential)

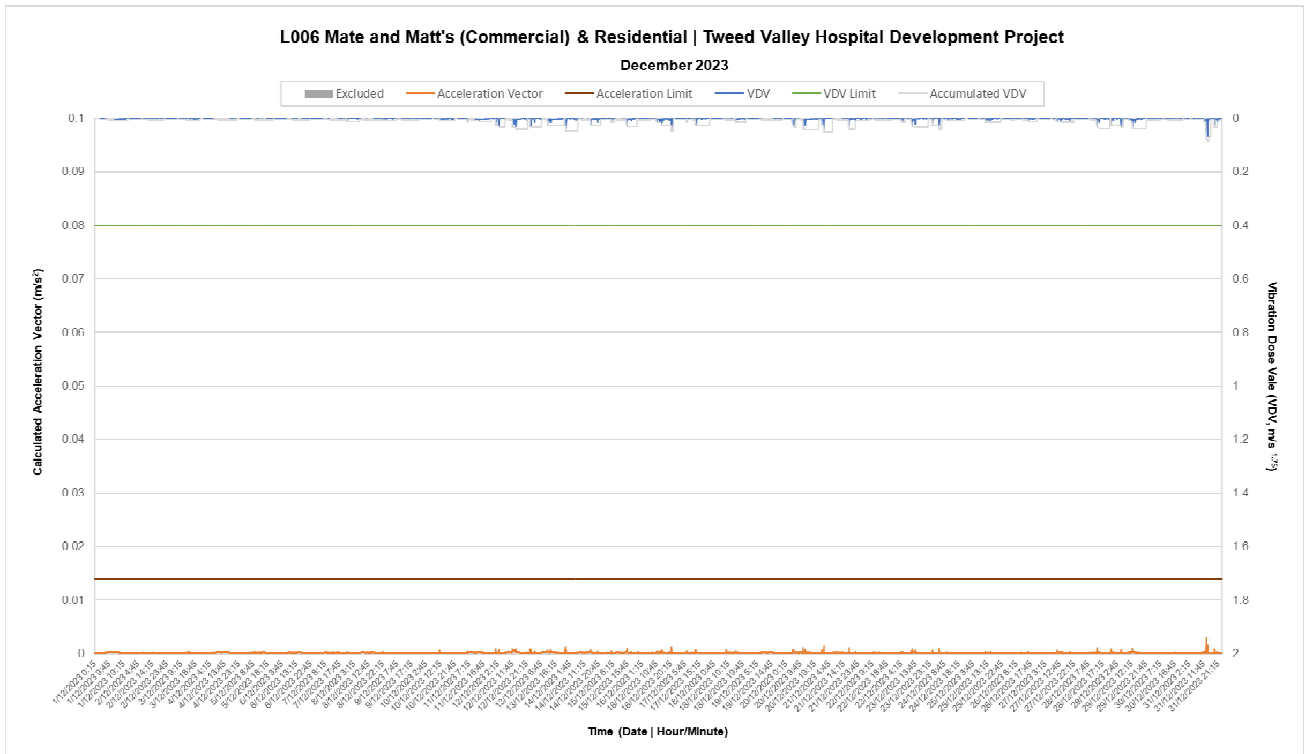
At Location L006 and L007, no reported acceleration or VDV levels of concern has been identified. The maximum VDV level measured across both locations is  $0.0029 \text{ m/s}^{1.75}$  and no impact is noted. This maximum level was measured at Location L006 on the 31 December 2023 for the 1:30PM 15-minute period.

Figure 6 overleaf presents iVDV, accumulated VDV (per period), and weighted RMS Acceleration ( $\alpha_{\text{rms}}$ ) data able to be obtained from L006.

**Figure 6** Acceleration and Vibration Dose Value over time (Logger 006 – Residential/Commercial)

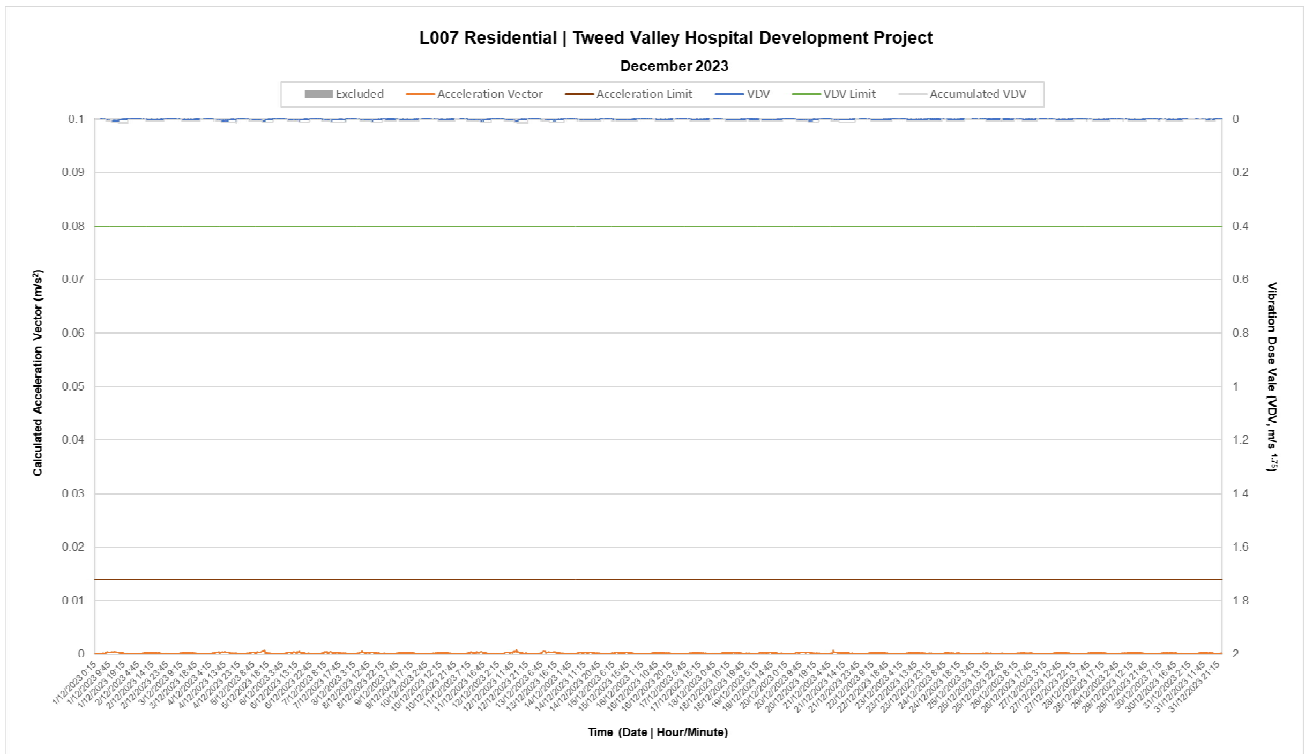
**Figure 7** which follows presents vibration dose at the southwestern residential receiver at Location L.007.

**Figure 7** Acceleration and Vibration Dose Value over time (Logger 007 – Residential)

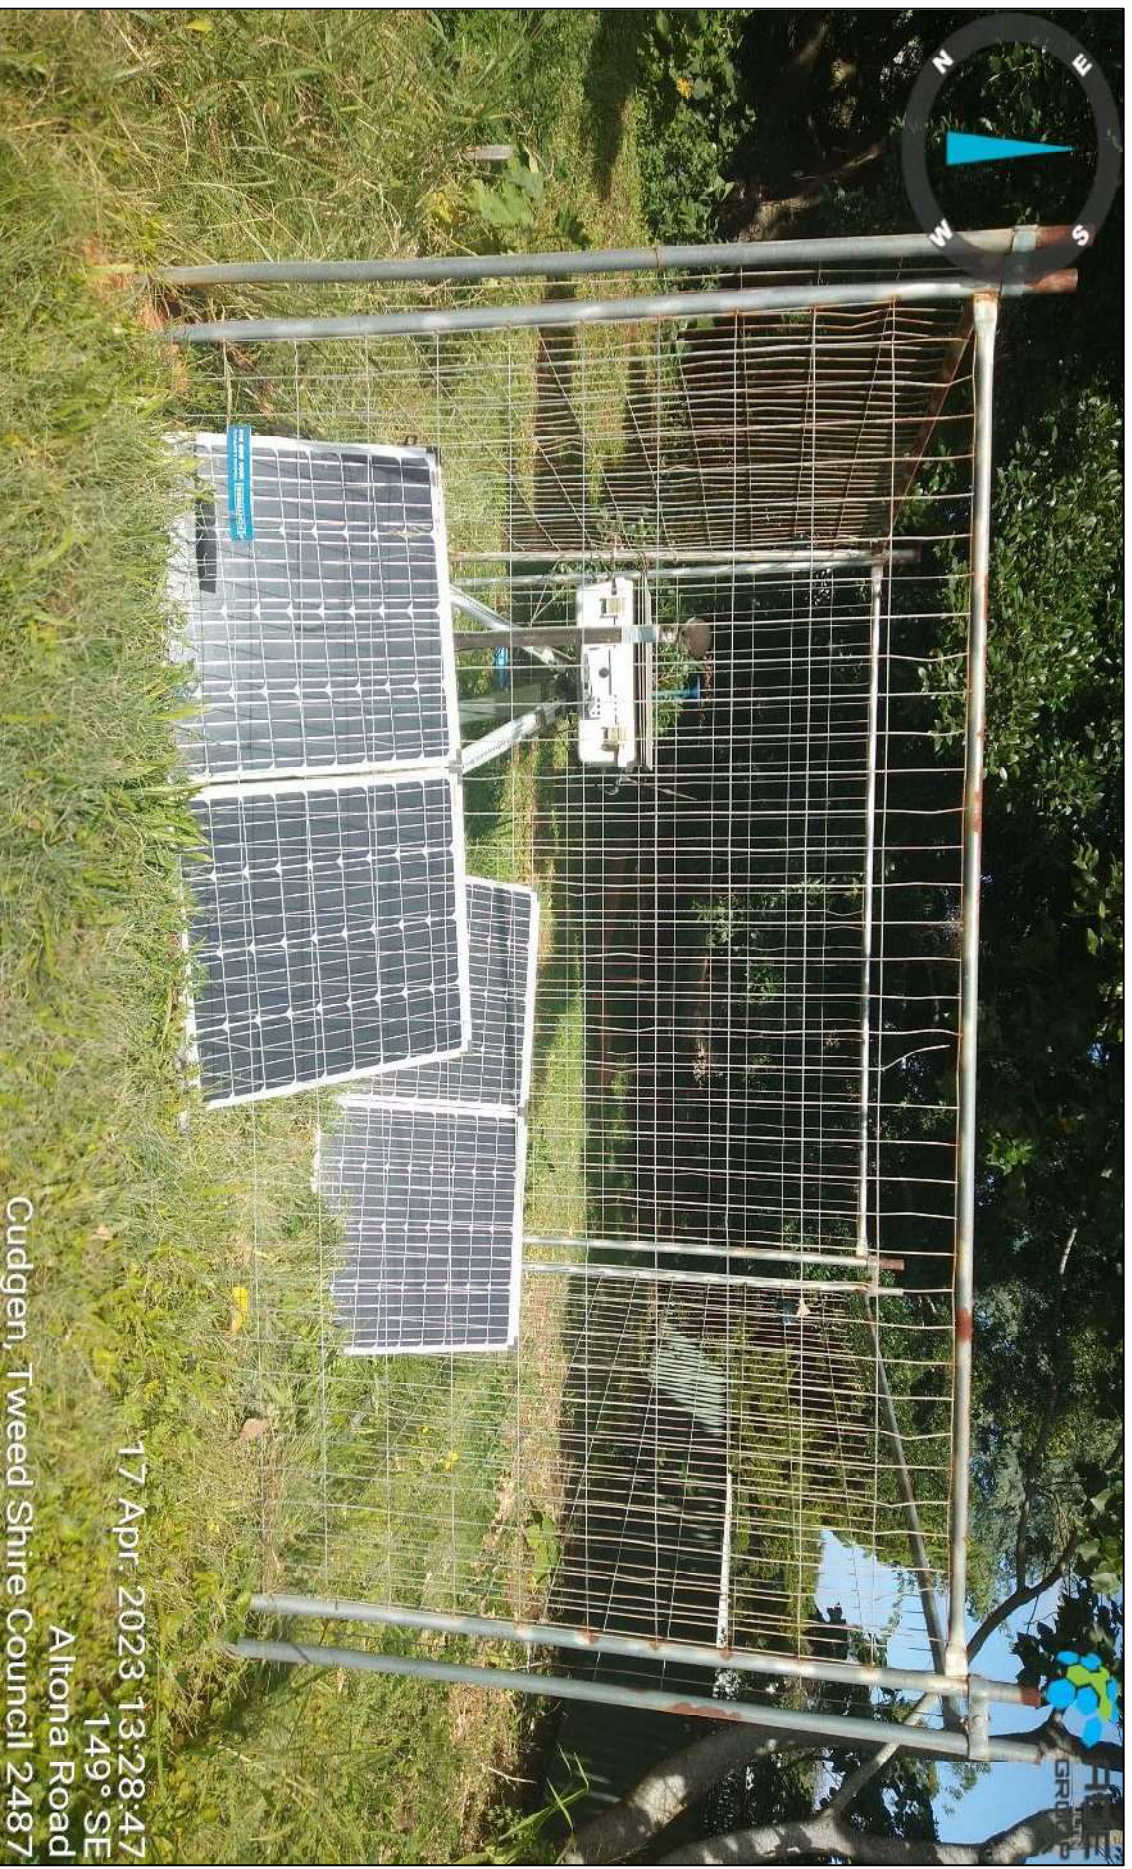
As noted previously, due to the continued instrument malfunction at L005 there was no noise or vibration data to proceed with any analysis for this location. Despite this data loss from this location, historical reporting from all three locations shows a strong correlation with one another (especially with L007), and it is considered highly unlikely that any vibration impacts at this location during December would have been differed to that experienced at L007.

Photograph 2 Representative photograph of monitoring location 005 – Solar Industry, as observed 17/04/2023
