# **Environmental Dust Assessment Report (September 2023)**

**Tweed Valley Hospital Project, Cudgen NSW**

A101021.0286.00 | EDM49.Rev0 | Date: 10/11/2023

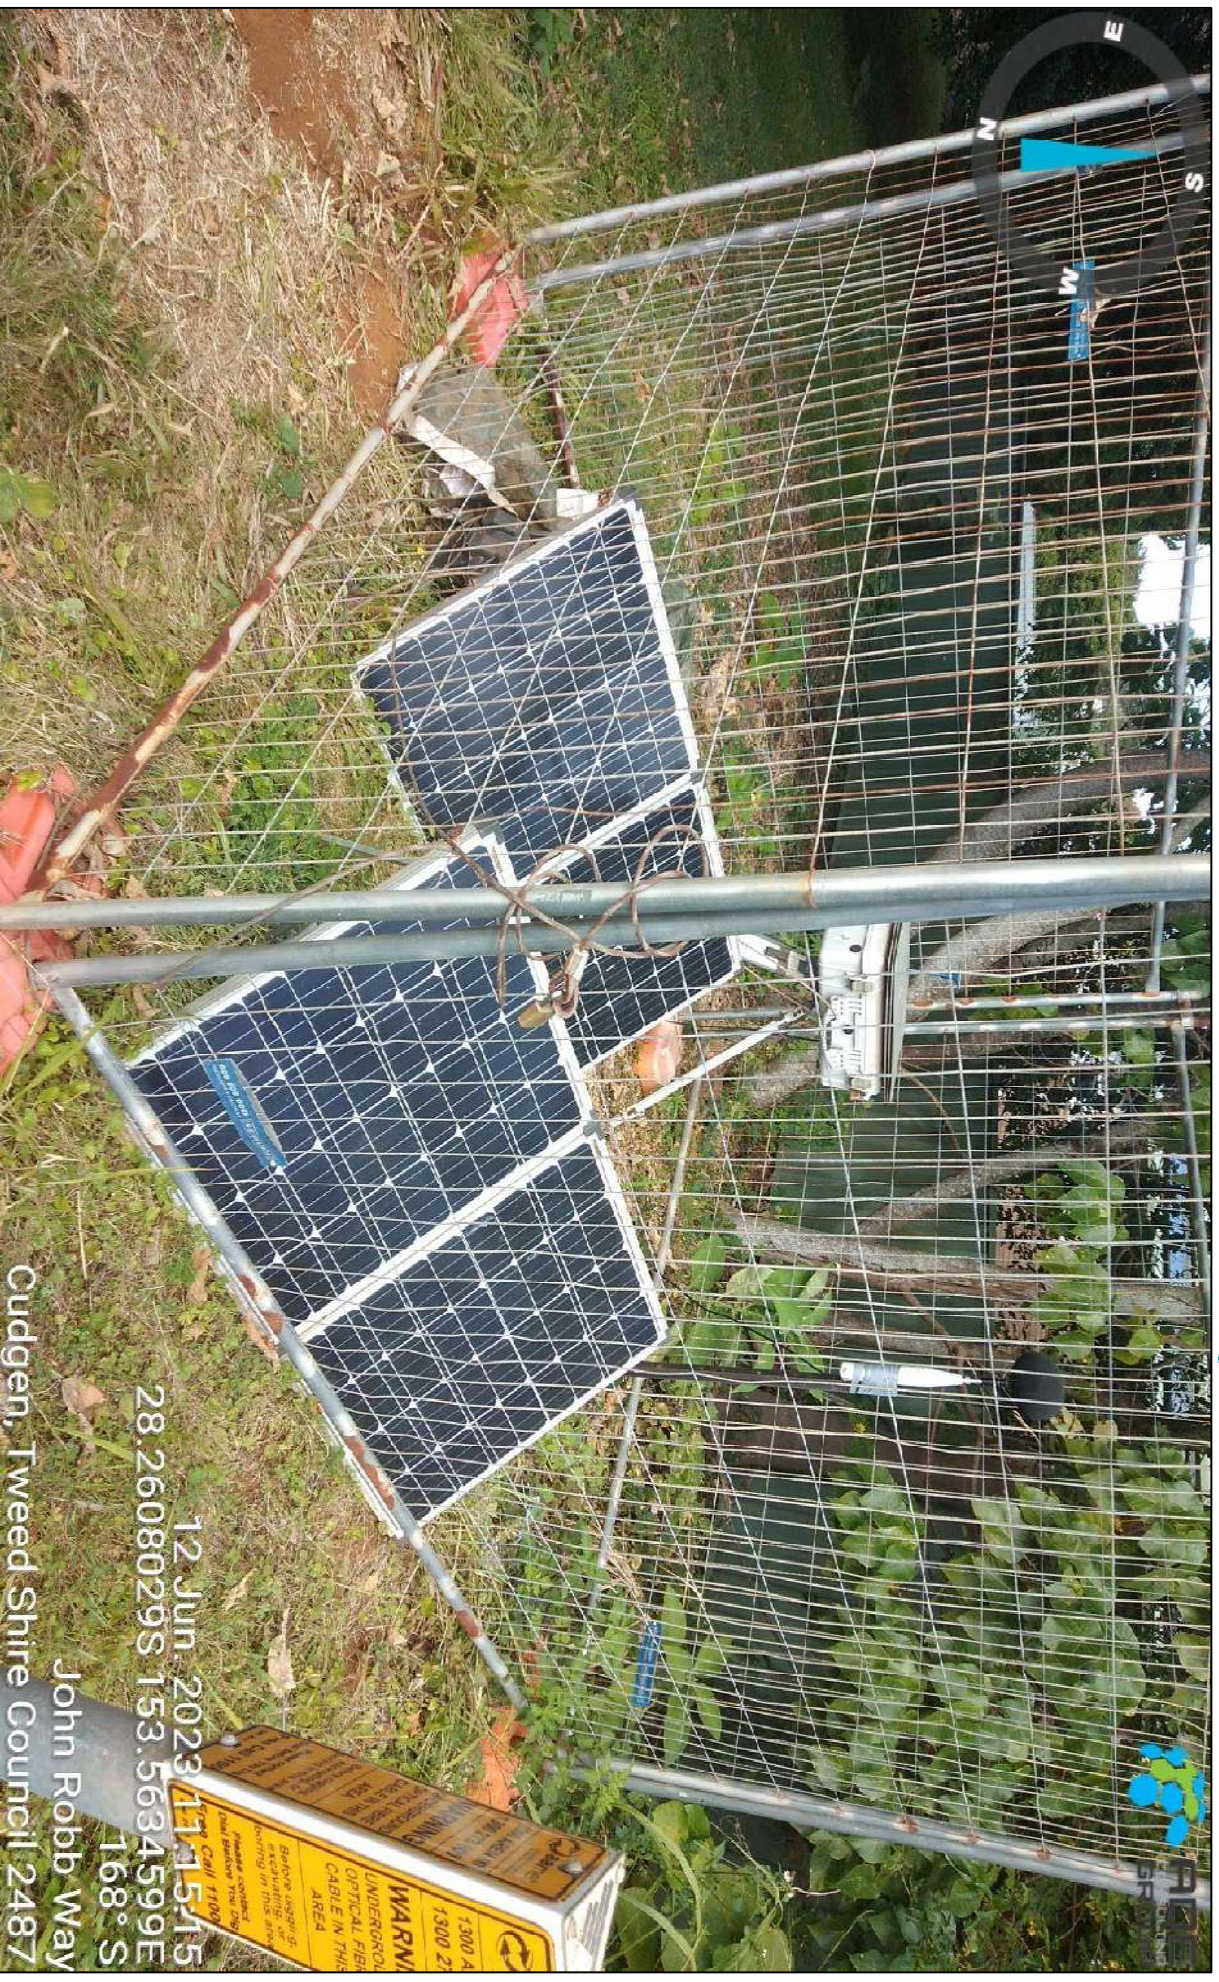
Dust Monitor 005 was observed to be offline sporadically towards the end of September.

During the reported monitoring period, data was missing from the 17<sup>th</sup> to the 30<sup>th</sup> of September.

Photograph 1: Representative photograph of monitoring location 005 – Solar Industry, as observed 12/06/2023

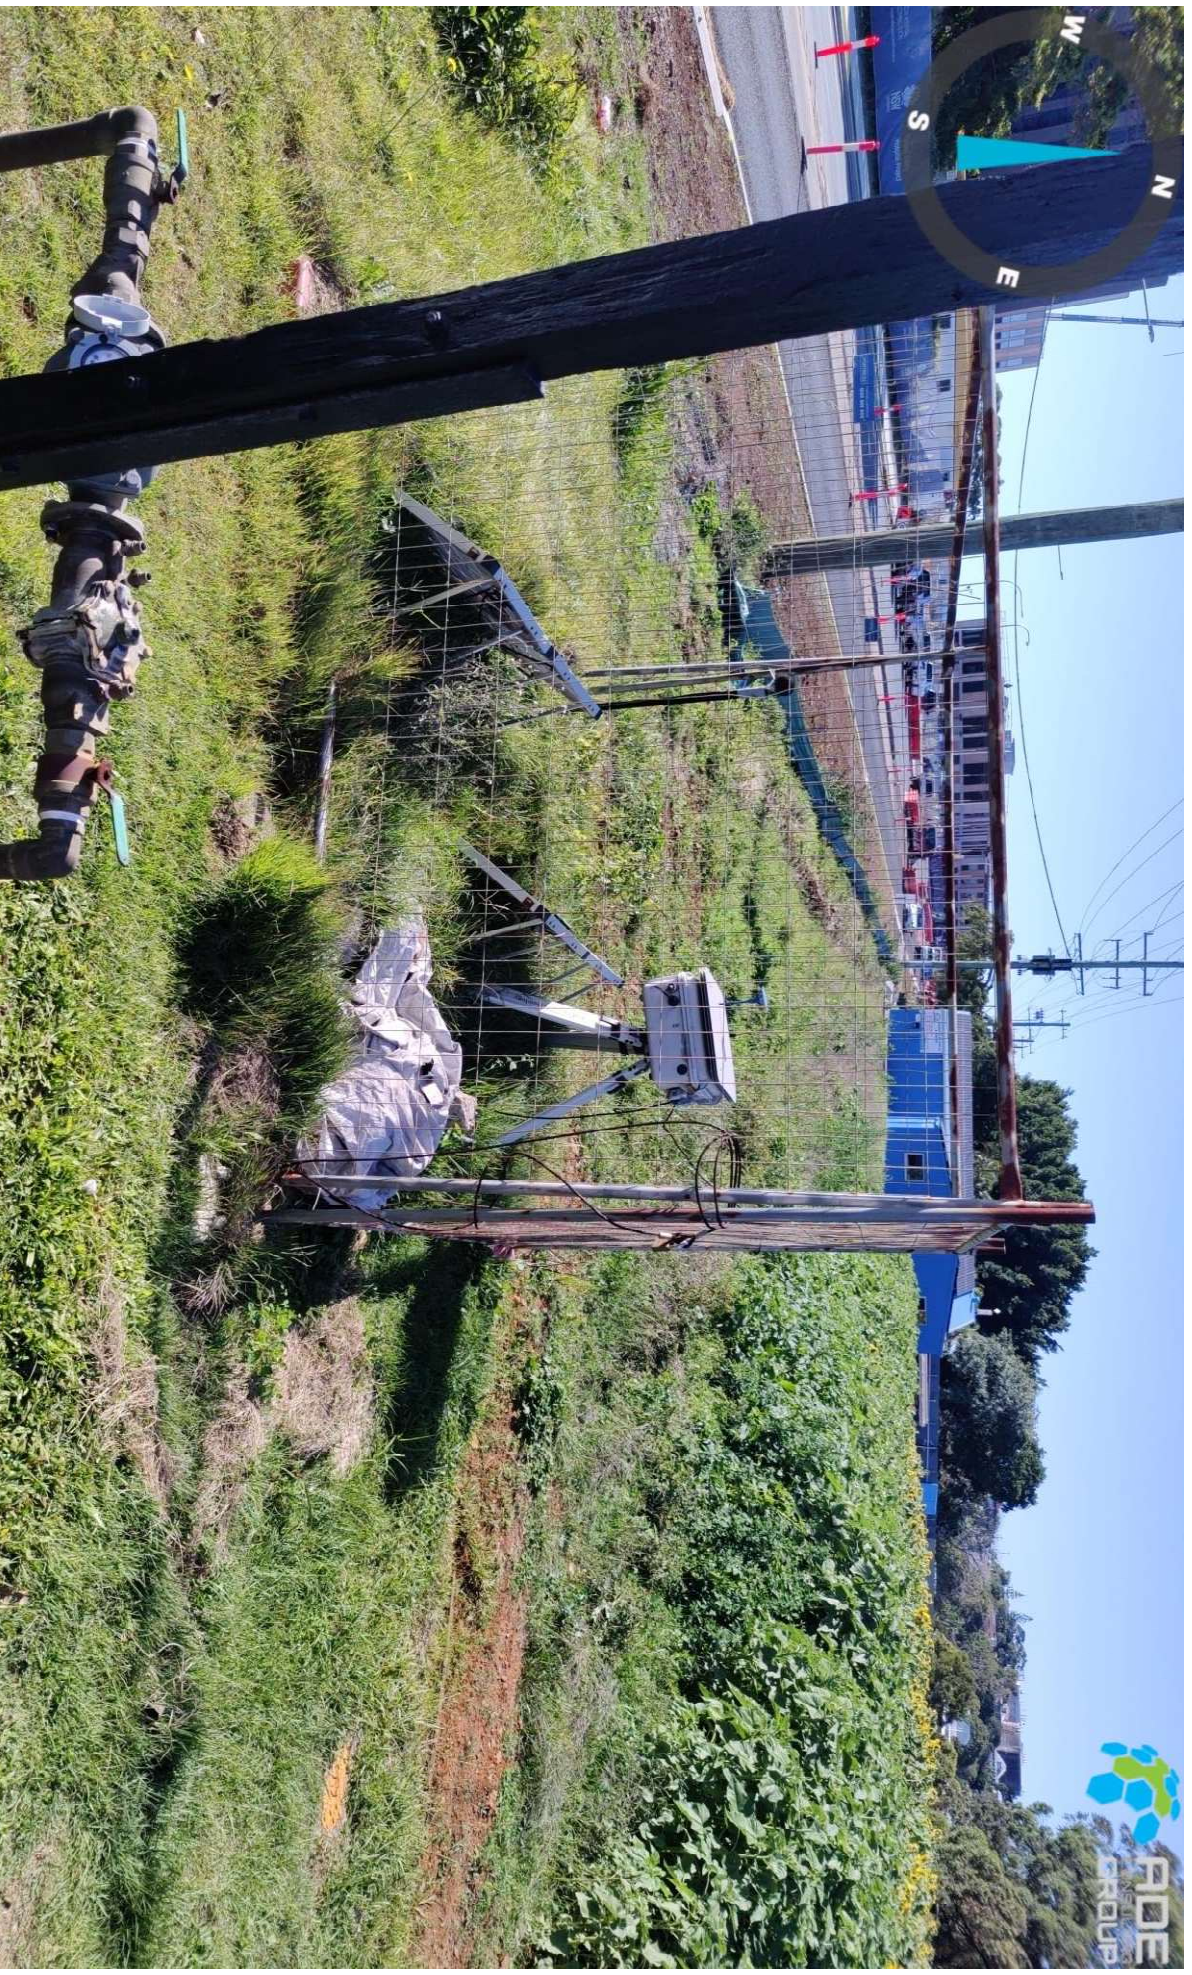
During the reported monitoring period, data was missing from the 27<sup>th</sup> to the 30<sup>th</sup> of September.

Photograph 2: Representative photograph of monitoring location 006 – Mate and Matts, as observed 12/06/2023

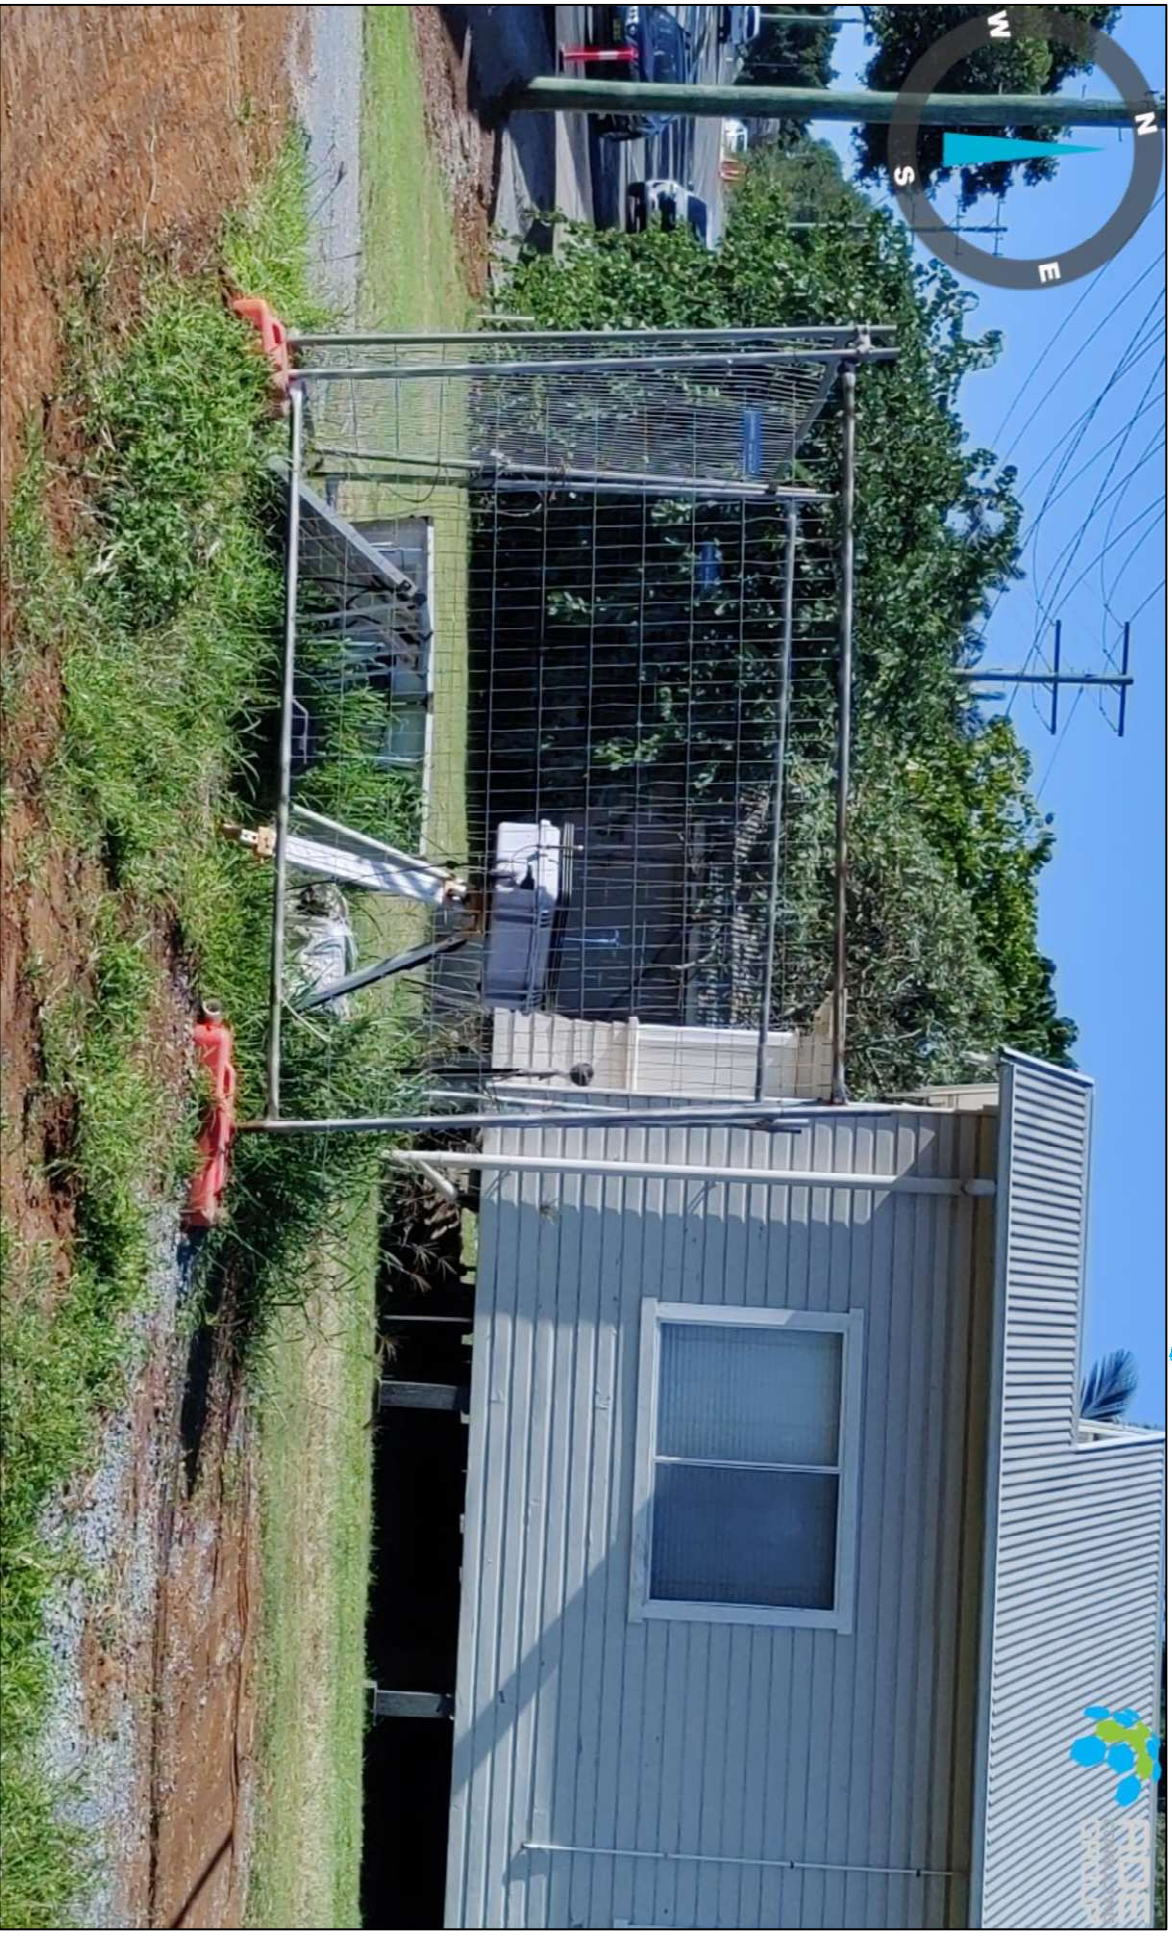
Photograph 3: Representative photograph of monitoring location 007 – Residential, as observed 12/06/2023
